COLUMBIA

ACCIDENT INVESTIGATION BOARD

REPORT VOLUME I
AUGUST 2003

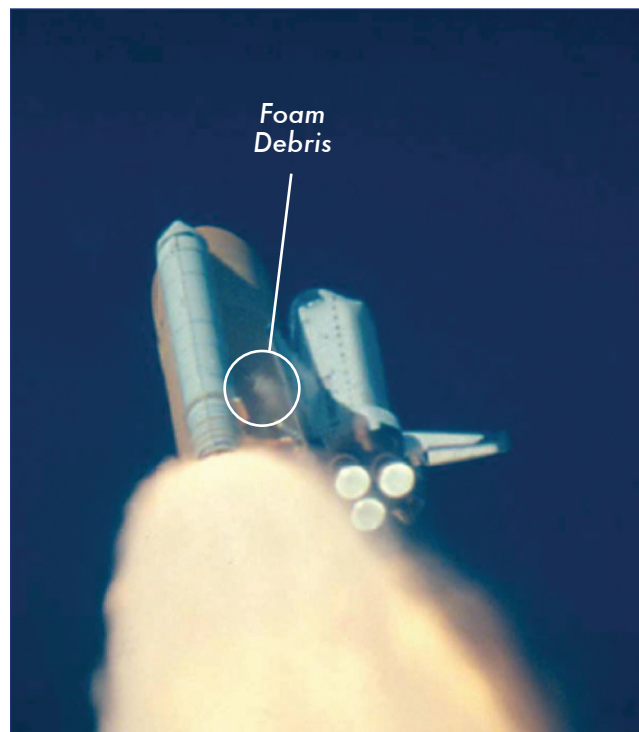
Figure 2.3-2. A shower of foam debris after the impact on *Columbia's* left wing. The event was not observed in real time.

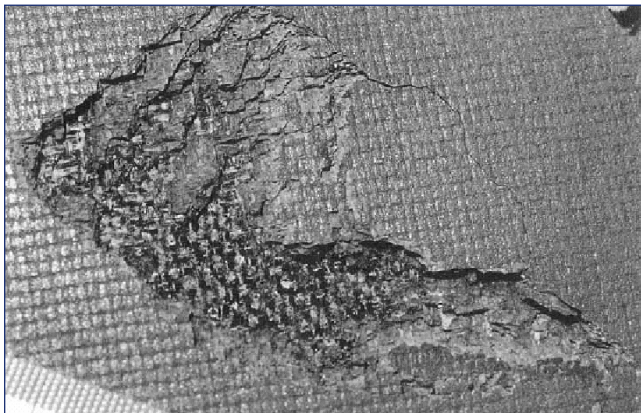
Figure 3.3-2. Damage on the outer surface of RCC panel 10-right from *Atlantis* after STS-45.

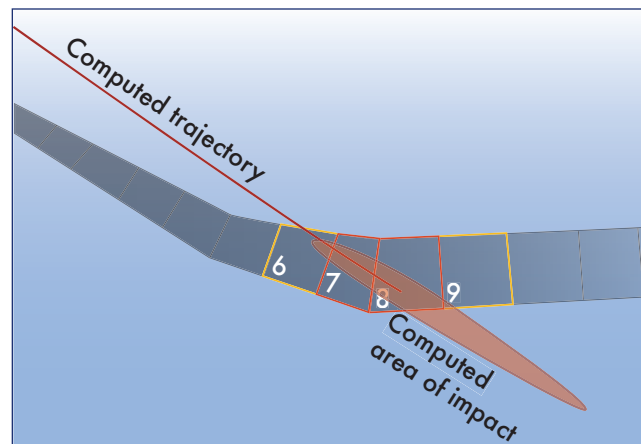
Figure 3.4-3: The best estimate of the site of impact by the center of the foam.
