# STS-1 Orbiter Final Mission Report

August 1981

**Lyndon B. Johnson Space Center**  
Houston, Texas

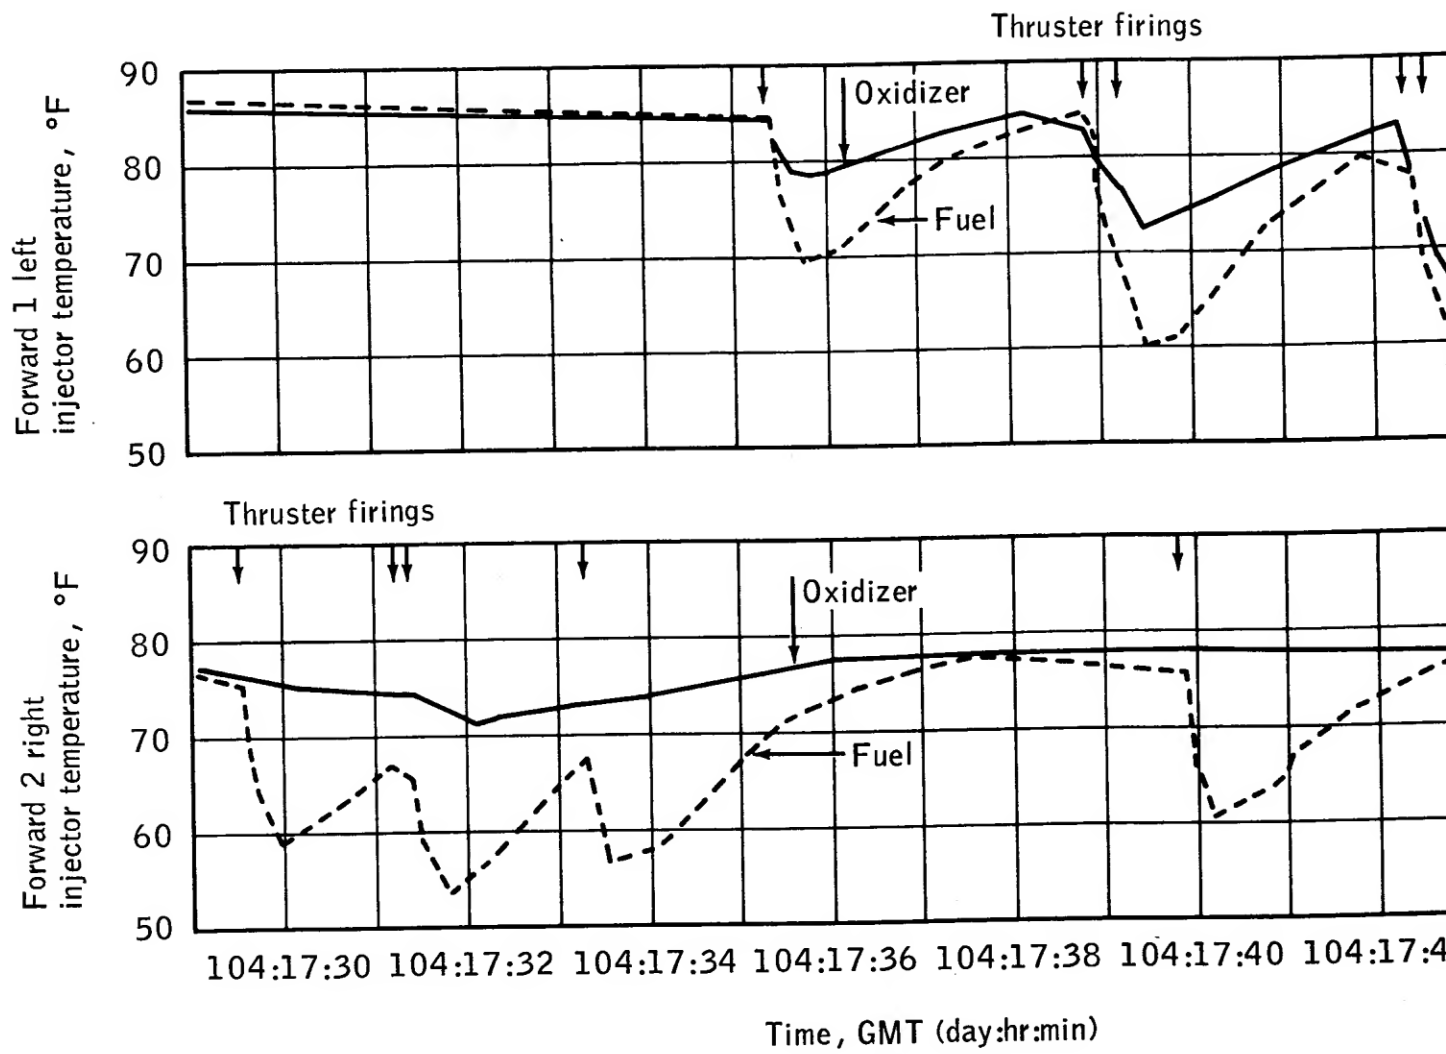
The oxidizer leak detector on thruster forward 2 right (F2R) did not track the transient evaporation cooldown that occurred on the fuel leak detector. An apparent thermal open exists between the oxidizer leak detector and the injector tube, and, therefore, a large thermal lag exists between the tube temperature and what the leak detector senses (fig. 2-4). See section 8.0, flight test problem report 50, for a discussion of this anomaly.

Figure 2-4.- Oxidizer leak detector - injector tube thermal log data.

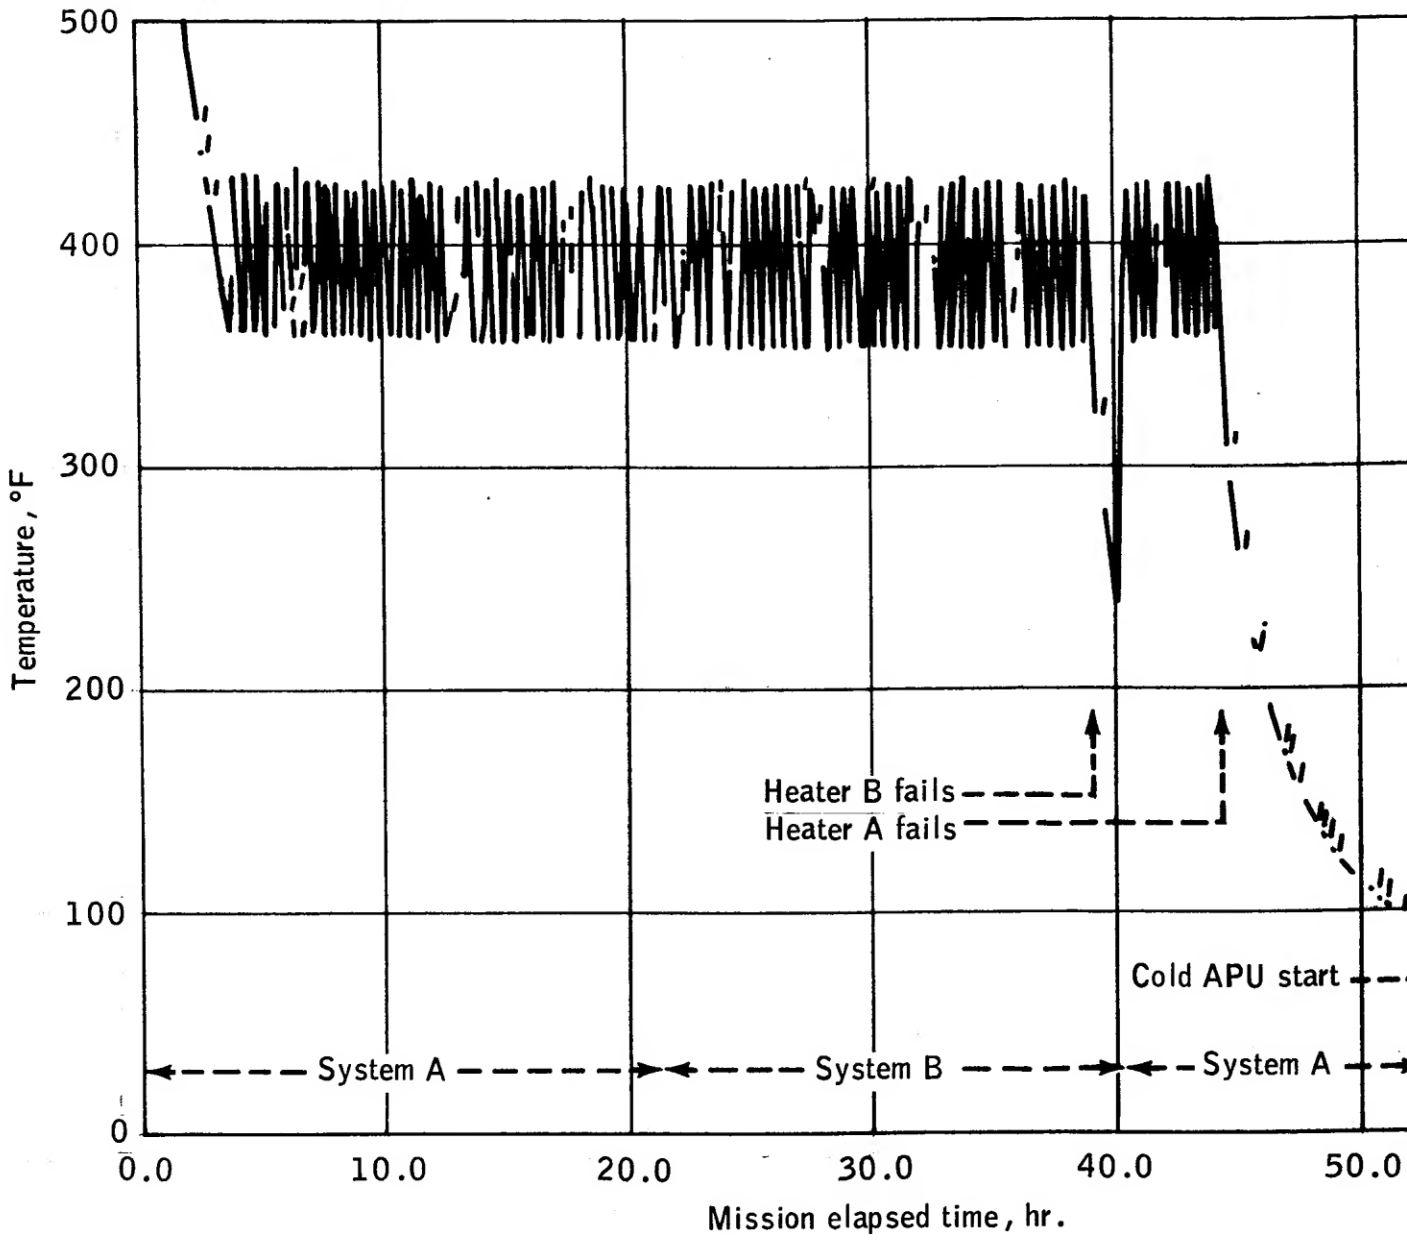
Failures occurred in both of the APU 2 gas generator heaters. Both failures occurred late in the mission, as shown in figure 2-5 (see section 8.0, flight test problem report 19). The fuel pump and valve temperatures were 75° to 80° F, and the gas generator temperature was 88° F at APU start. The cool gas generator temperature necessitated a "start override" start of APU 2, and this initiated 209 sec of injector cooling before starting. APU 2 started within 4 sec after the cooling cycle was completed.

Figure 2-5.- APU gas generator heater failures

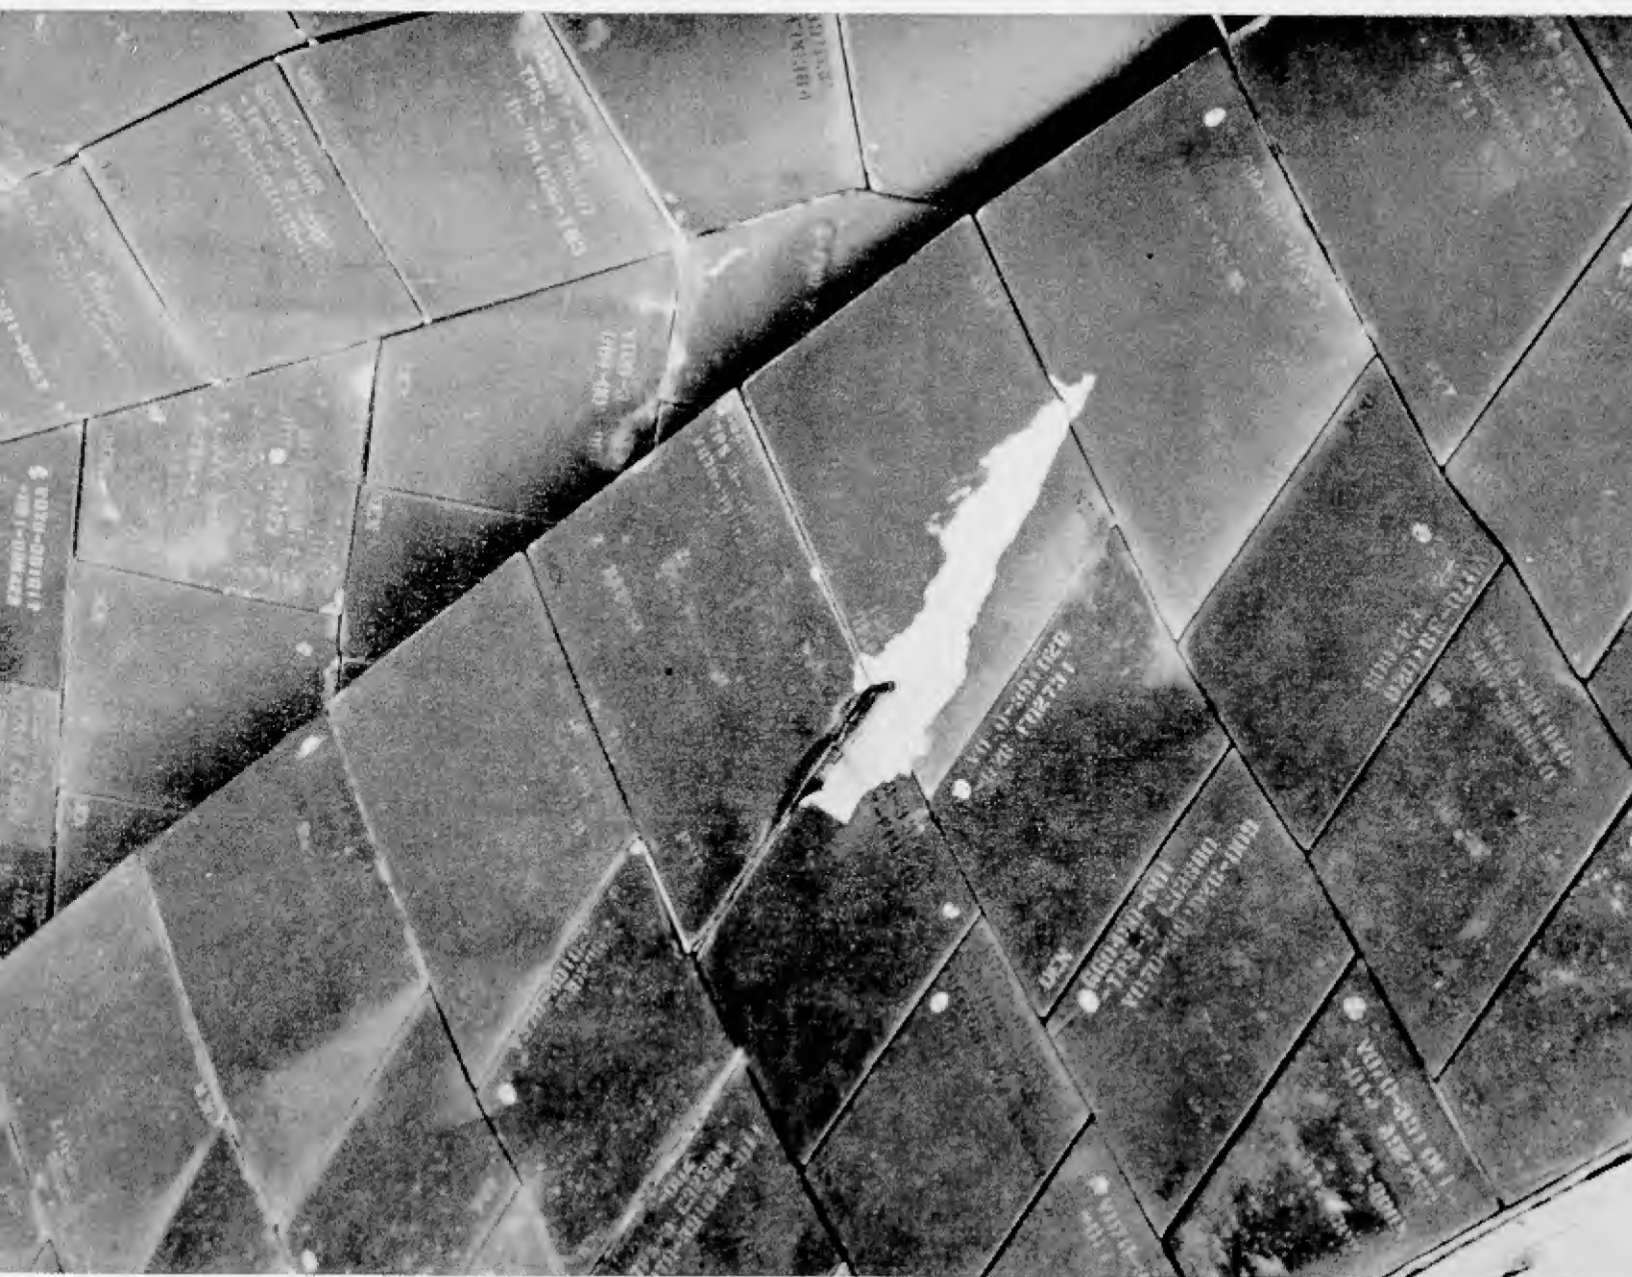
Figure 2-21.- Thermal damage to right nose landing gear door.

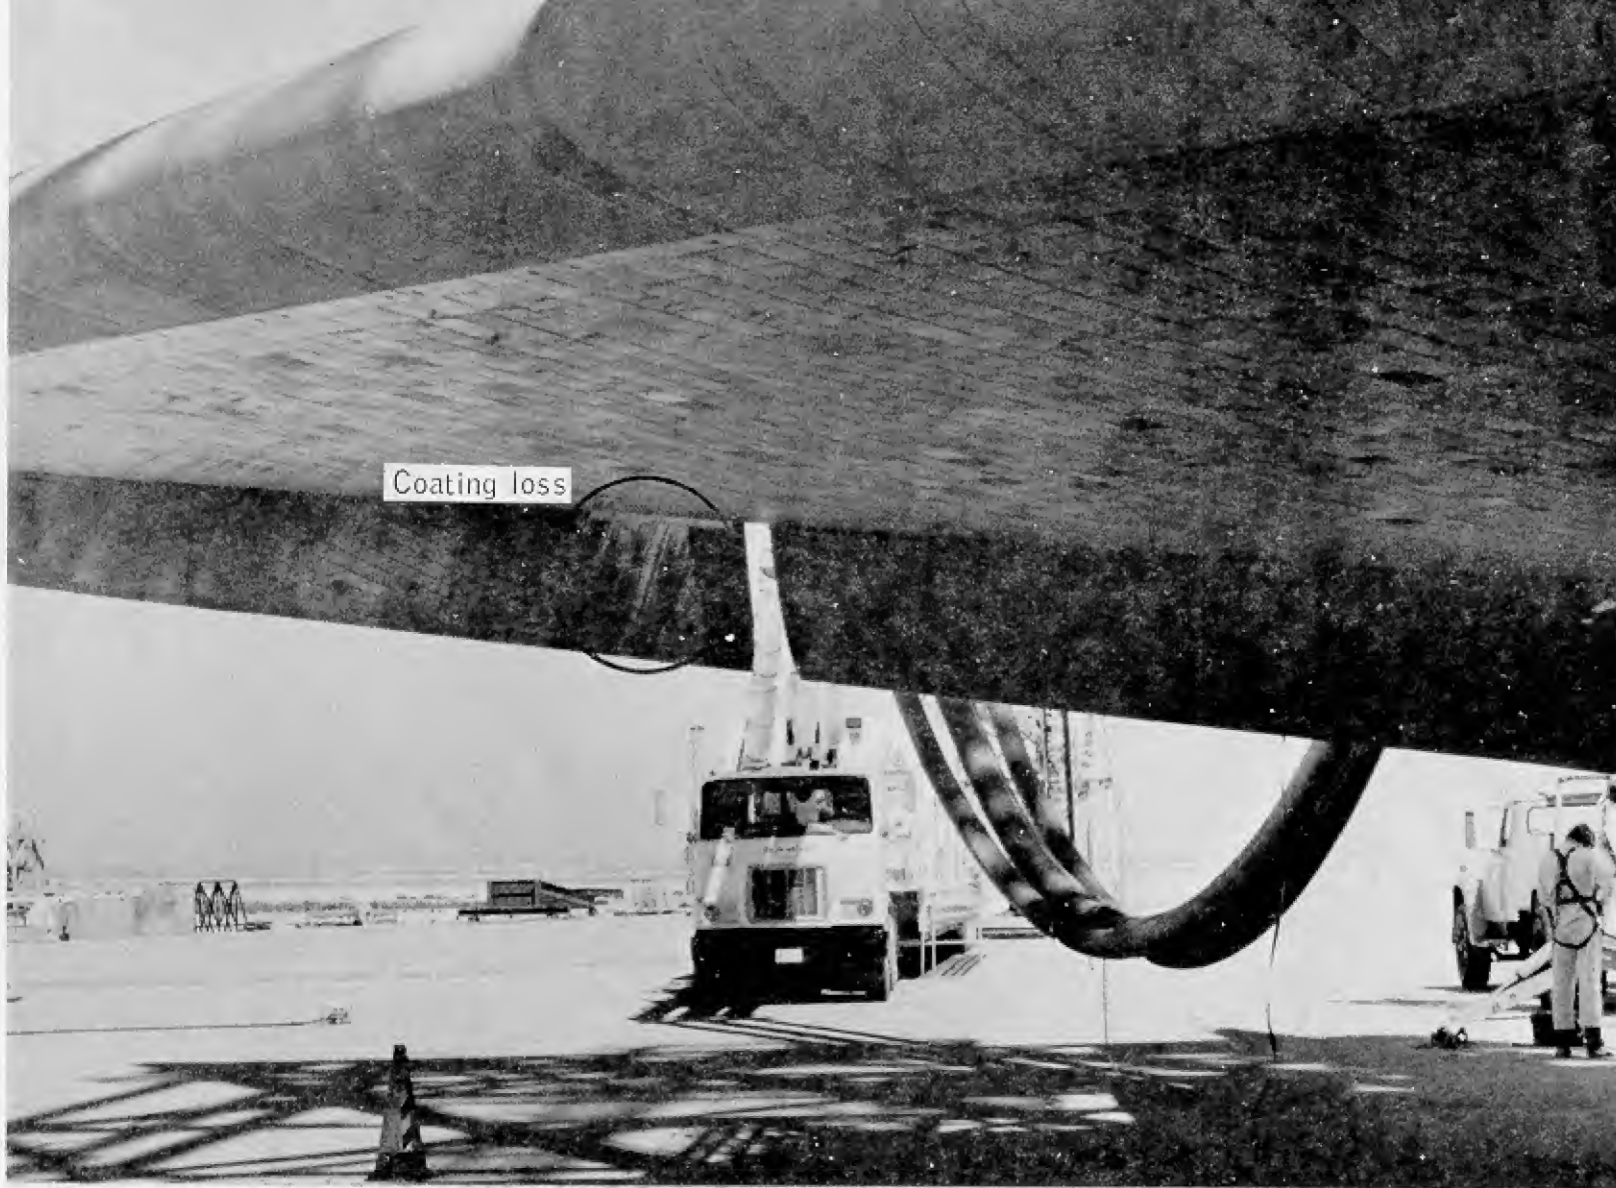
Figure 2-22.- Coating loss on lower surface of right inboard elevon.

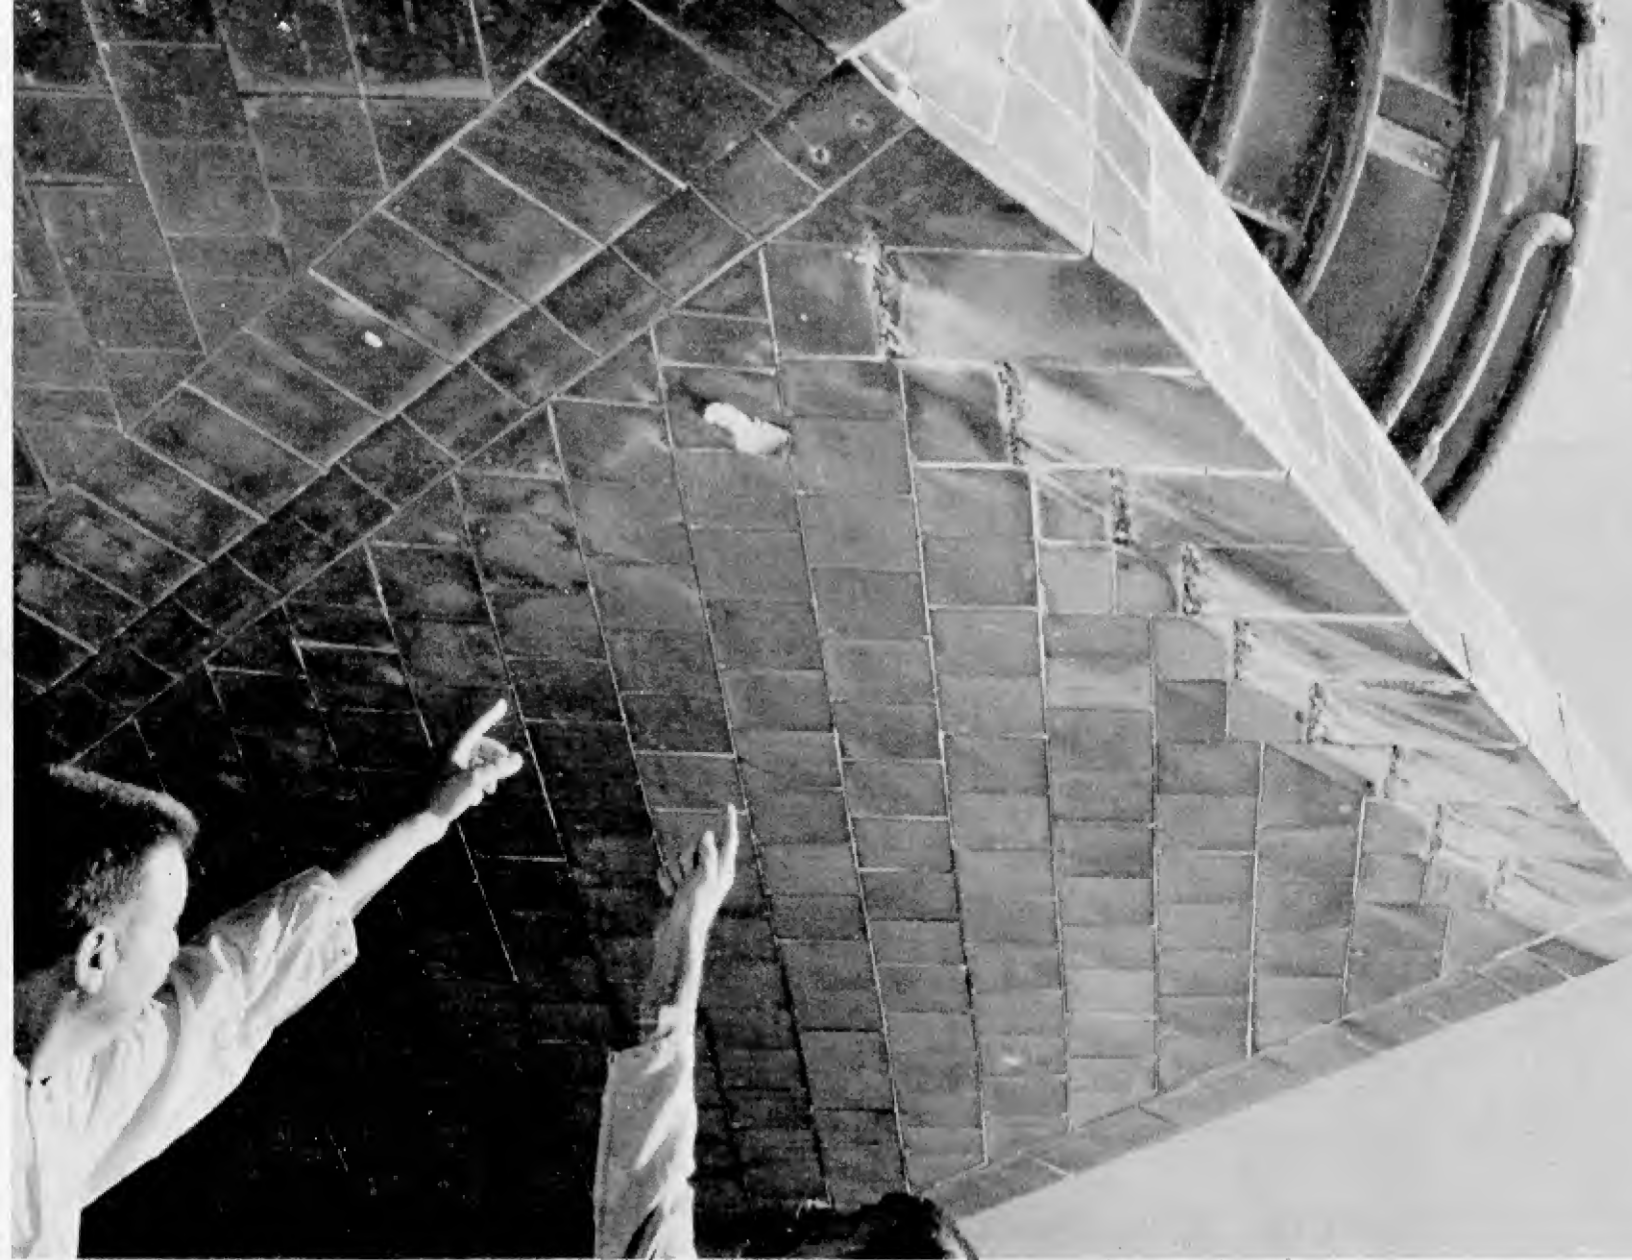
Figure 2-23.- Impact damage to left lower forward region of body flap.

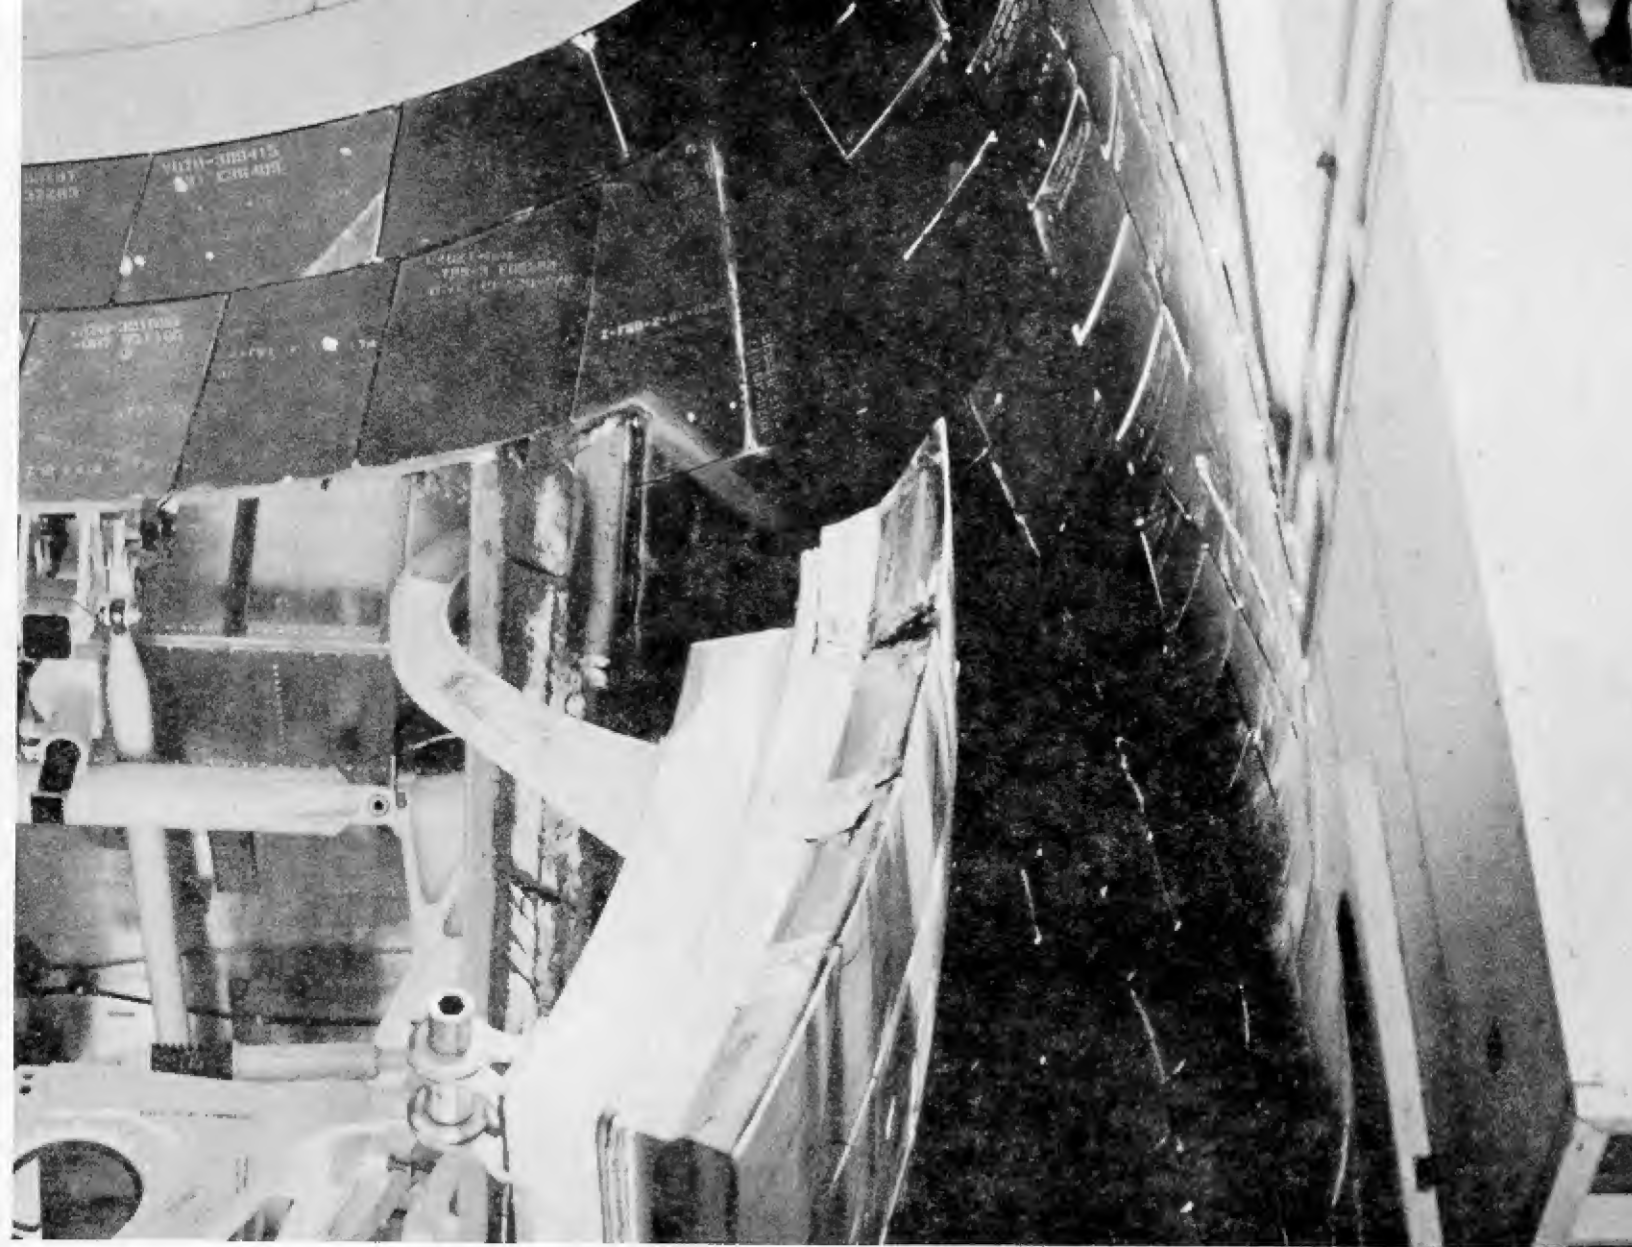
Figure 2-25.- Breaching of thermal barrier on leading edge of left nose gear door.

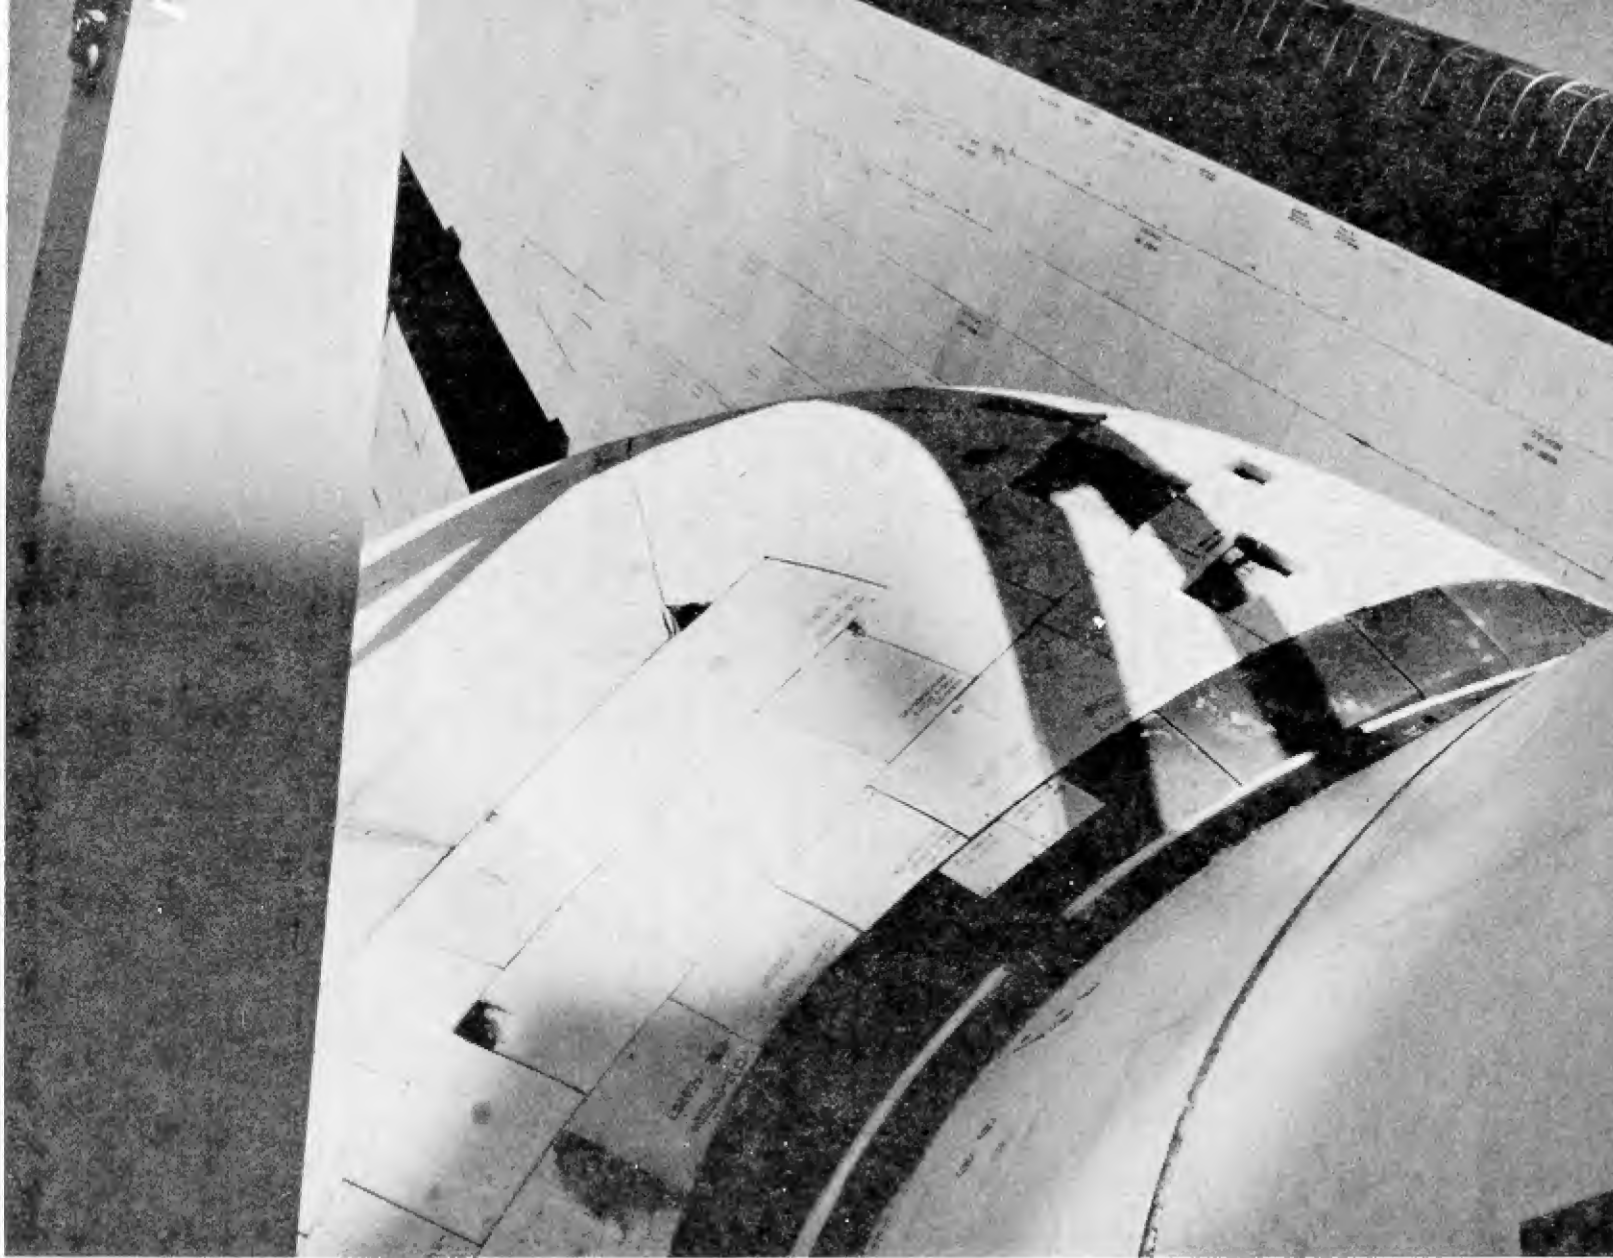
Figure 2-26.- Areas of lost tile on right OMS pod.

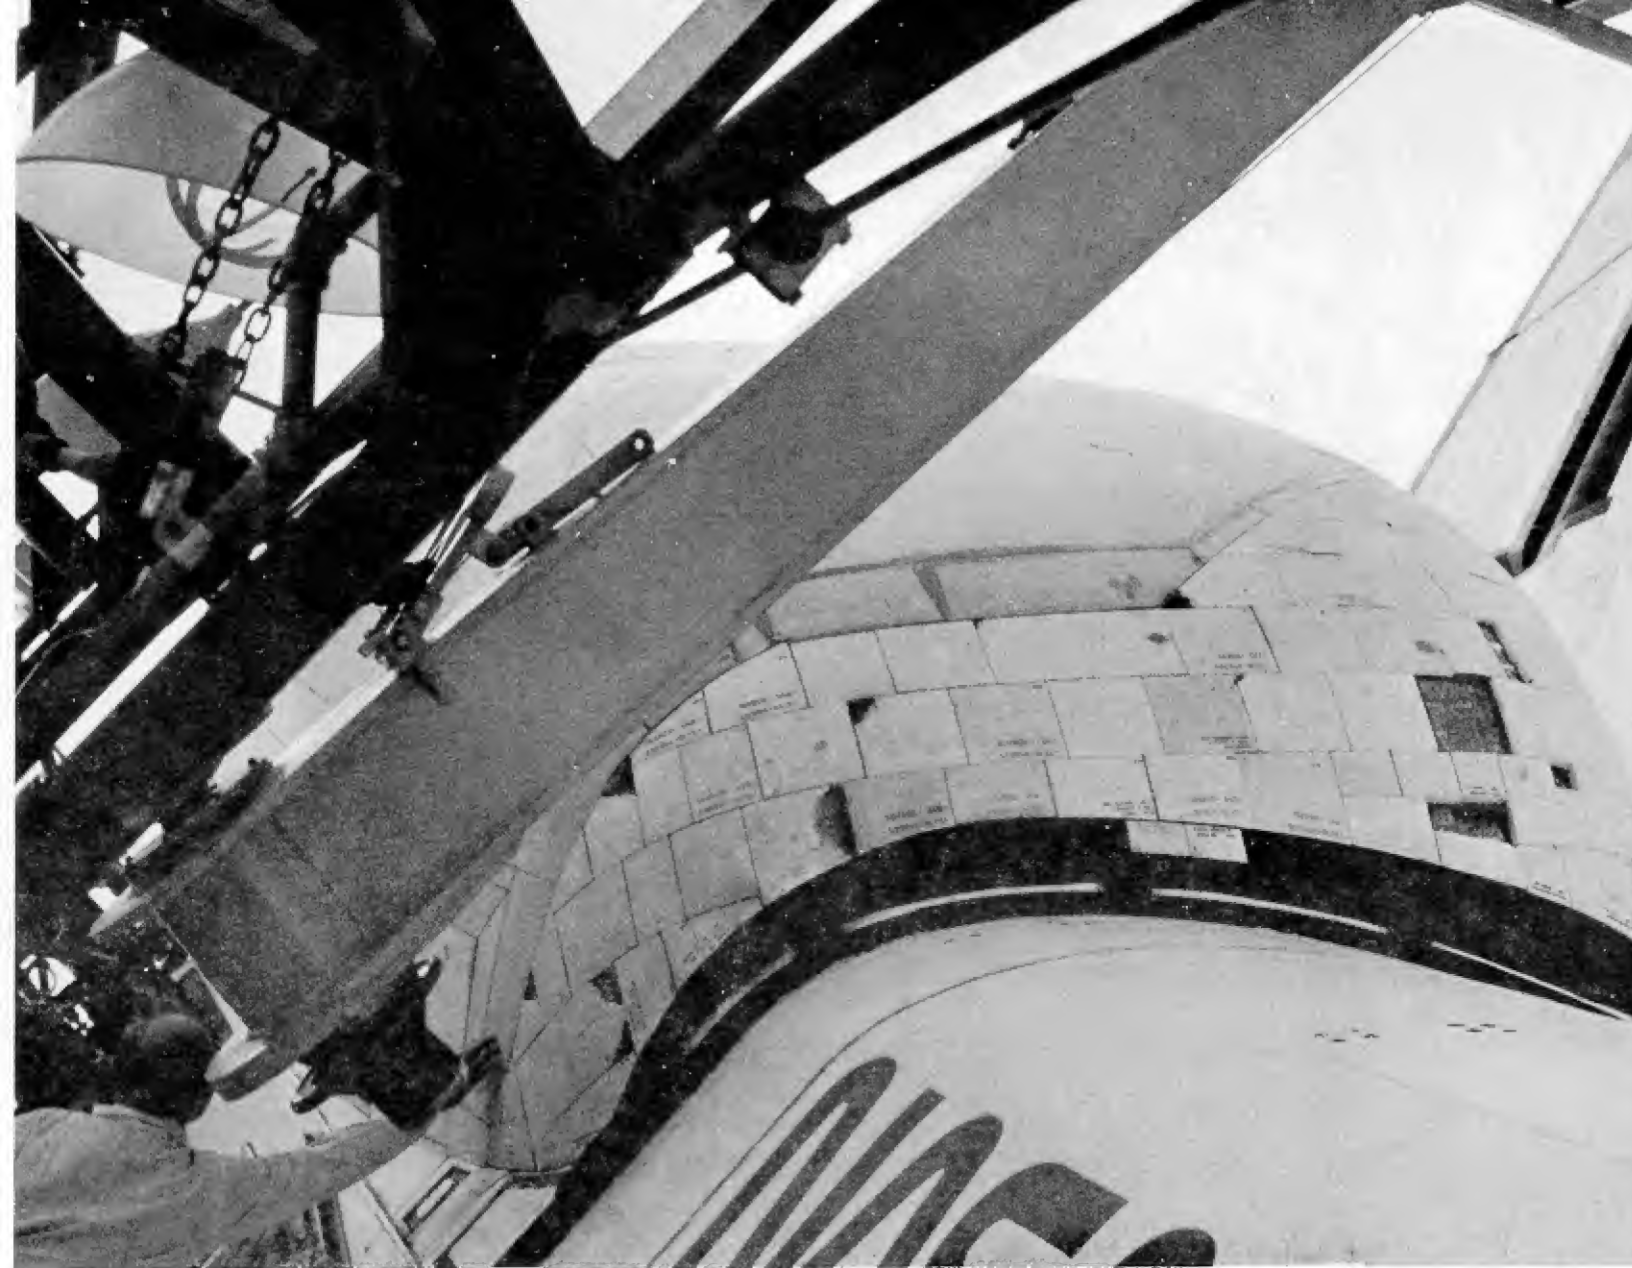
Figure 2-27.- Scorching of tile on forward edge of OMS pod.

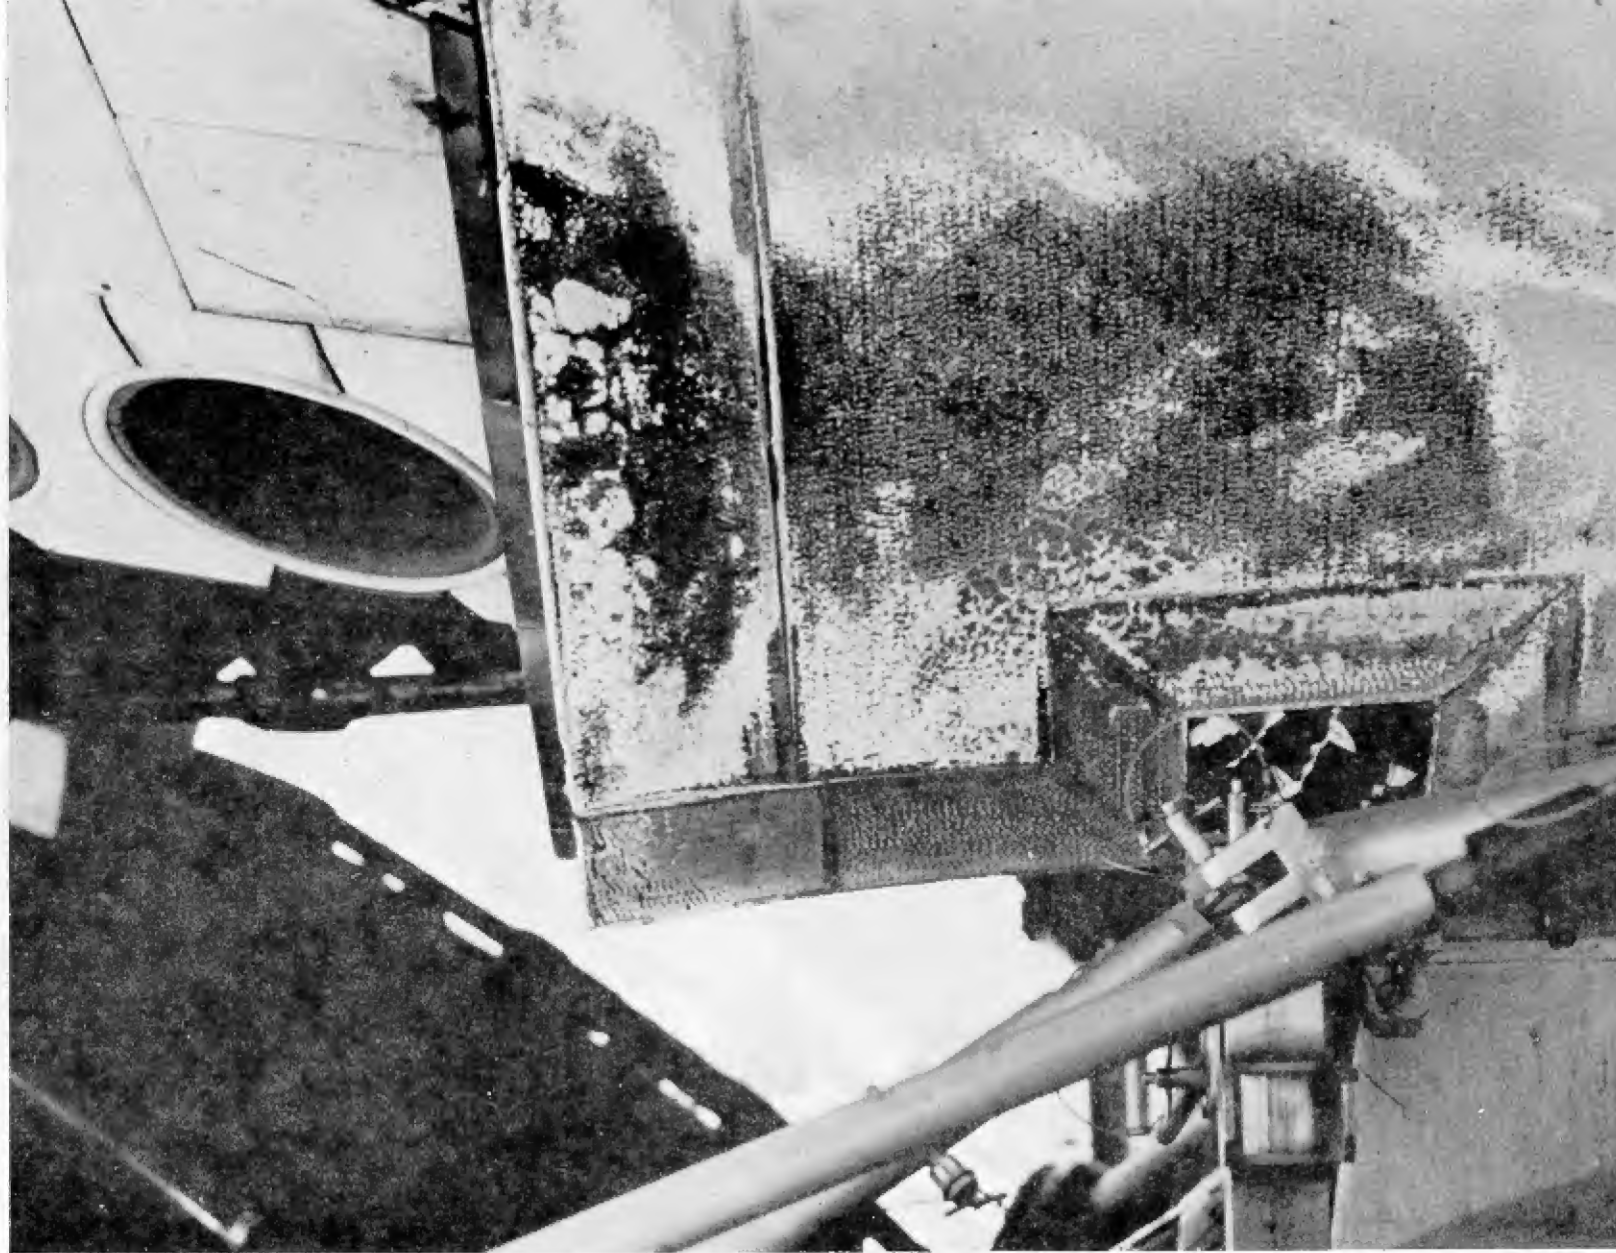
Figure 2-28.- Delamination of OMS pod structure.
