**STS-1 Forward RCS Oxidizer Tank Subsystem
Failure Assessment**

K. Chauncey Wu

**2021 AIAA Science and Technology
Forum and Exposition**
11-15 & 19-21 January 2021

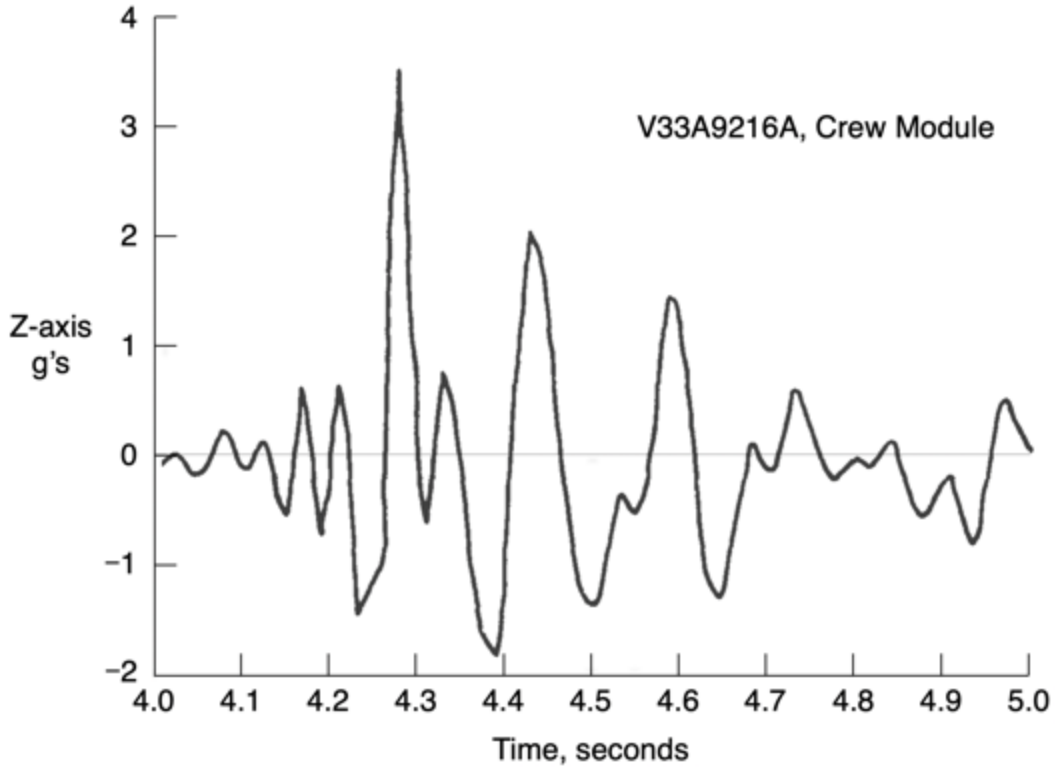
Figure 8. Measured liftoff Z acceleration (Ref. 5)

As described in Fig. 3, “(t)he ... strut failed ... due the lift-off dynamic response from the SRB overpressure.” Liftoff Z accelerations measured in the orbiter cockpit (Fig. 8) were reported in Refs. 4 and 5 to have a maximum value of +3.5 g and a minimum of -2.0 g , with a peak-to-peak acceleration of [+3.5 g - (-2.0 g)] or +5.5 g , and a natural frequency of approximately 9.6 Hz. Multiplication of these measured Z accelerations and the filled oxidizer tank mass gives estimates for the maximum inertial Z loading of 5,378 lbf, a minimum value of -3,073 lbf, and a peak-to-peak loading of 8,451 lbf.

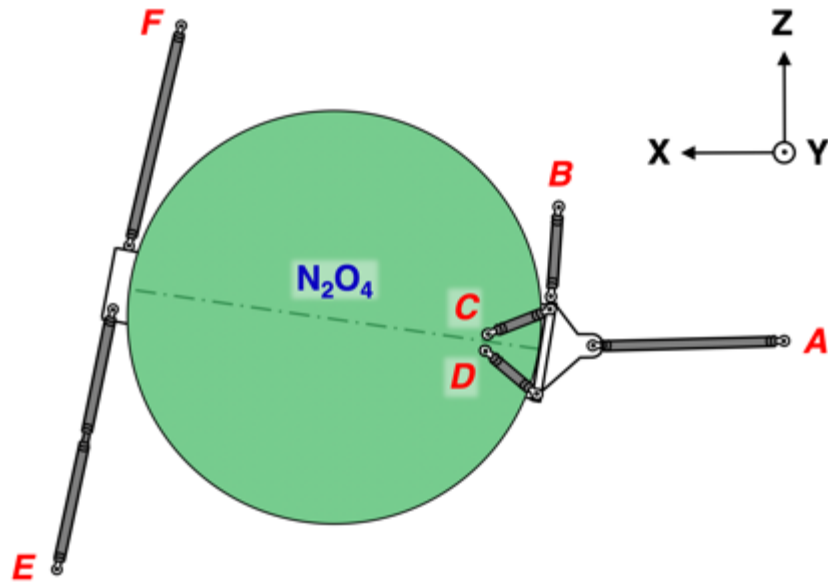
Figure 9. Tank subsystem inboard profile view

The FRCS oxidizer tank and its support struts are viewed in the $-Y$ direction in Fig. 9. The six pinned-end Struts A through F , when attached to the FRCS module's structure, form a statically determinate set of constraints to prevent rigid-body motion of the tank (Ref. 17). The axial forces in Struts A through F can therefore be found from simultaneous solution of the six equilibrium equations,

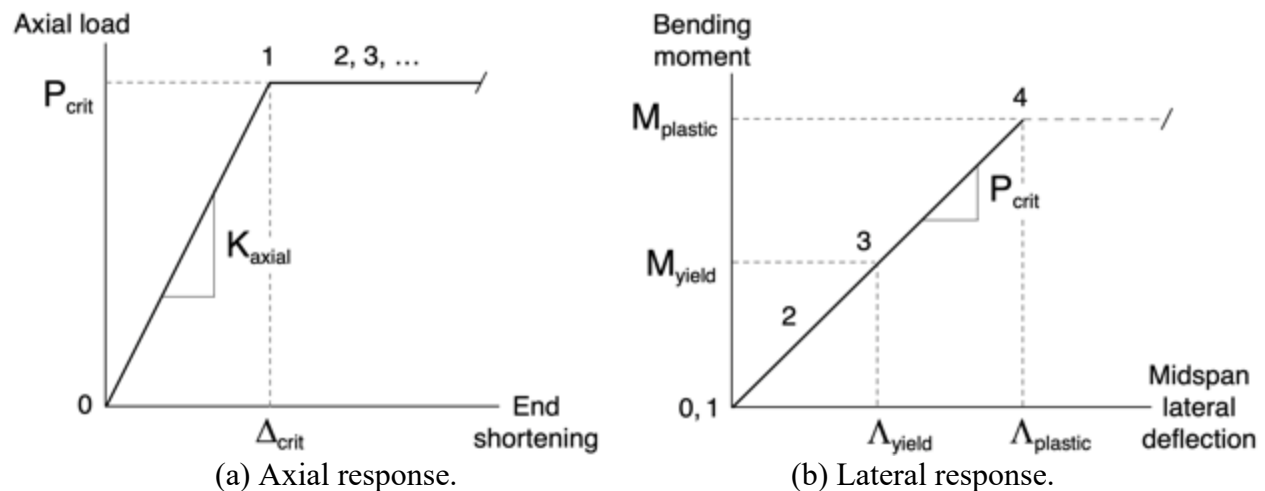
Figure 12. Strut structural response

The idealized axial load-deformation behavior of this strut is assumed to be linear with slope (*i.e.*, axial stiffness) K_{axial} up to buckling at P_{crit} , as plotted schematically along path 0-1 in Fig. 12a. The axial deformation Δ_{crit} corresponding to buckling is assumed to be the ratio of the buckling load P_{crit} and slope K_{axial} . The buckling load provides an upper limit for the strut axial load. After buckling the axial response is also linear but with zero slope, following path 1-2 as shown in the figure.

The idealized strut pre-buckling response of axial compression, no bending, and no lateral deflection (path 0-1) transitions rapidly at buckling (point 1) to post-buckling. This post-buckling response (path 1-2) has nonzero bending under constant axial load P_{crit} , indeterminate axial deformation $\Delta > \Delta_{crit}$, and lateral deflection $\Lambda > 0$. Under a linear combination of the buckling load and increasing bending, the resulting strut response is linear-elastic up to the onset of material yielding at point 3 in Fig. 12b.

For a sufficiently large bending moment, the material yields across the strut midspan and a plastic hinge (Ref. 21) will develop at point 4 in Fig. 12b. This failure represents a limiting value beyond which the strut would collapse and become a mechanism. The lateral deflection then increases without bound, as indicated by the horizontal dashed line in the figure. For a thin-walled tube, this plastic moment M_{plastic} is derived as,

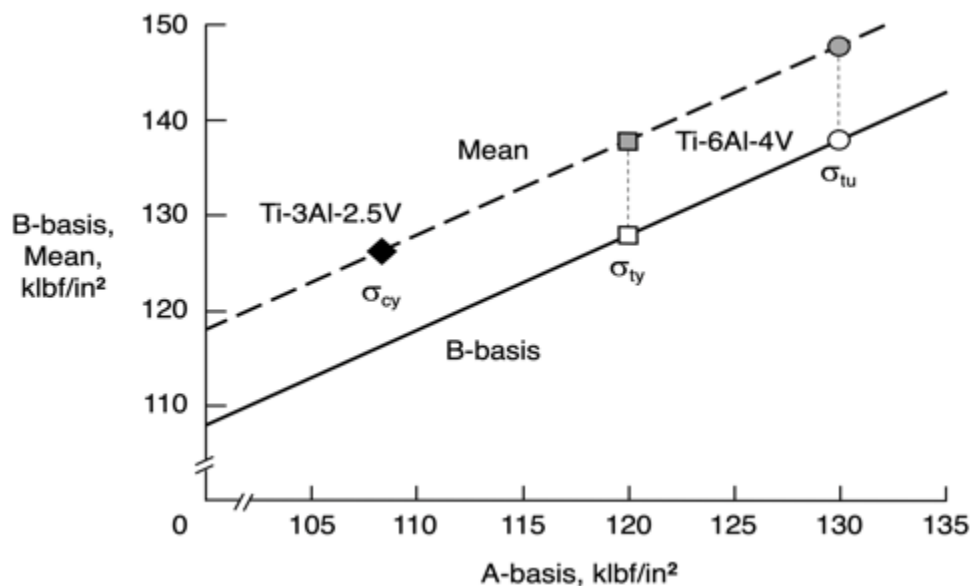
Figure B1. Titanium stress values

Simultaneous solution of these equations for the mean tensile ultimate stress gives σ_{tu-m} , $= 147.83 \text{ klf/in}^2$, and a standard deviation $S = 7.67 \text{ klf/in}^2$. A similar solution for the mean tensile yield stress gives $\sigma_{ty-m} = 137.83 \text{ klf/in}^2$, with the same standard deviation $S = 7.67 \text{ klf/in}^2$. These mean values are shown in Fig. B1 as the gray circle and square, respectively. The linear relationship between the A-basis and B-basis tensile stresses is plotted as the solid line in Fig. B1, and the corresponding relationship between the A-basis and mean tensile stresses is plotted as the dashed line. The Ti-3Al-2.5V material used for the support struts has an A-basis design allowable compressive yield stress $\sigma_{cy-A} = -108 \text{ klf/in}^2$ (Ref. 14). The magnitude of that stress is assumed to correspond to a mean compressive yield stress $\sigma_{cy-m} = -125.83 \text{ klf/in}^2$, whose magnitude is plotted as the black diamond in Fig. B1.
