COLUMBIA

ACCIDENT INVESTIGATION BOARD

REPORT VOLUME I
AUGUST 2003

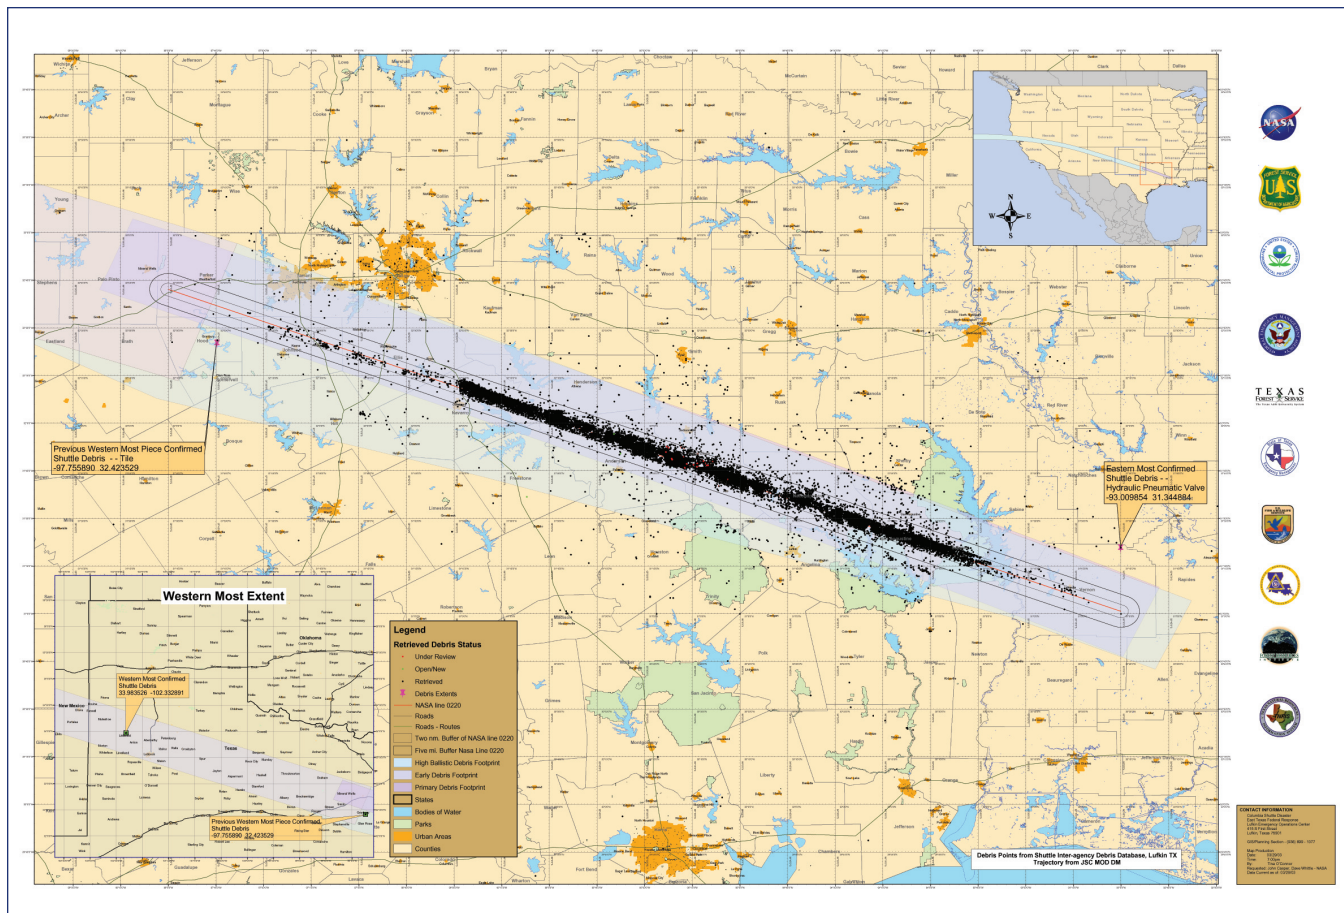
The emergency response that began shortly after 8:00 a.m. CST Saturday morning grew into a massive effort to decontaminate and recover debris strewn over an area that in Texas alone exceeded 2,000 square miles (see Figure 2.7-1). Local fire and police departments called in all personnel, who began responding to debris reports that by late afternoon were phoned in at a rate of 18 per minute.

Figure 2.7-1. The debris field in East Texas spread over 2,000 square miles, and eventually over 700,000 acres were searched.

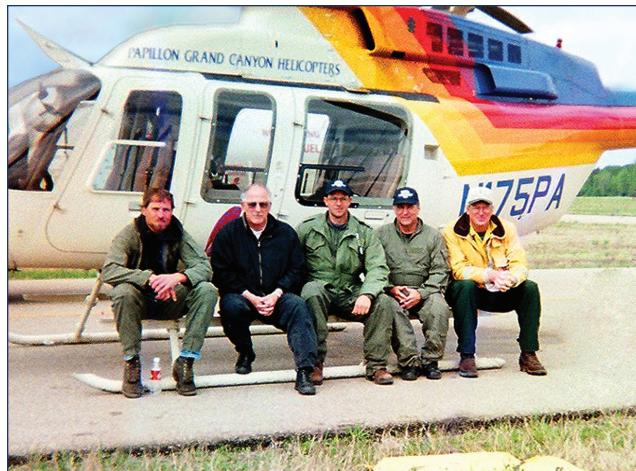
Figure 2.7-3. Tragically, a helicopter crash during the debris search claimed the lives of Jules "Buzz" Mier (in black coat) and Charles Krenek (yellow coat).

ty of the East Texas vegetation, the small sizes of the debris, and the inability of sensors to differentiate Orbiter material from other objects, these devices proved of little value. As a result, the detection work fell to spotter teams who visually scanned the terrain. Air search coordinators apportioned grids to allow a 50 percent probability of detection for a one-foot-square object. Civil Air Patrol volunteers and others in powered parachutes, a type of ultralight aircraft, also participated in the search, but were less successful than helicopter and fixed-wing air crews in retrieving debris. During the air search, a Bell 407 helicopter crashed in Angelina National Forest in San Augustine County after a mechanical failure. The accident took the lives of Jules F. "Buzz" Mier Jr., a contract pilot, and Charles Krenek, a Texas Forest Service employee, and injured three others (see Figure 2.7-3).

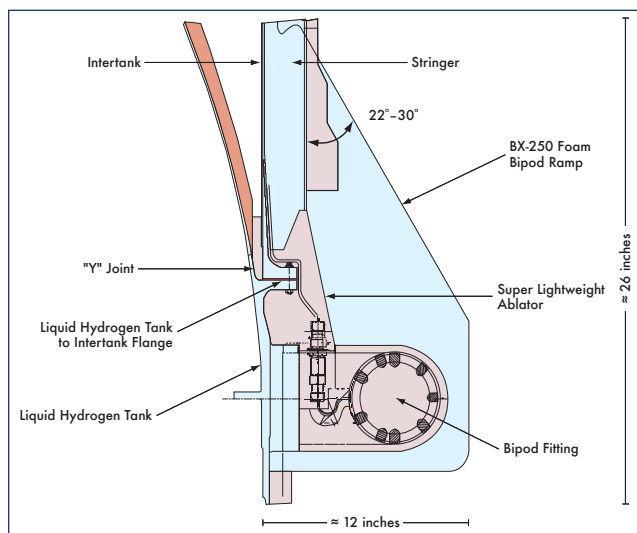
Figure 3.2-3. Cutaway drawing of the bipod ramp and its associated fittings and hardware.

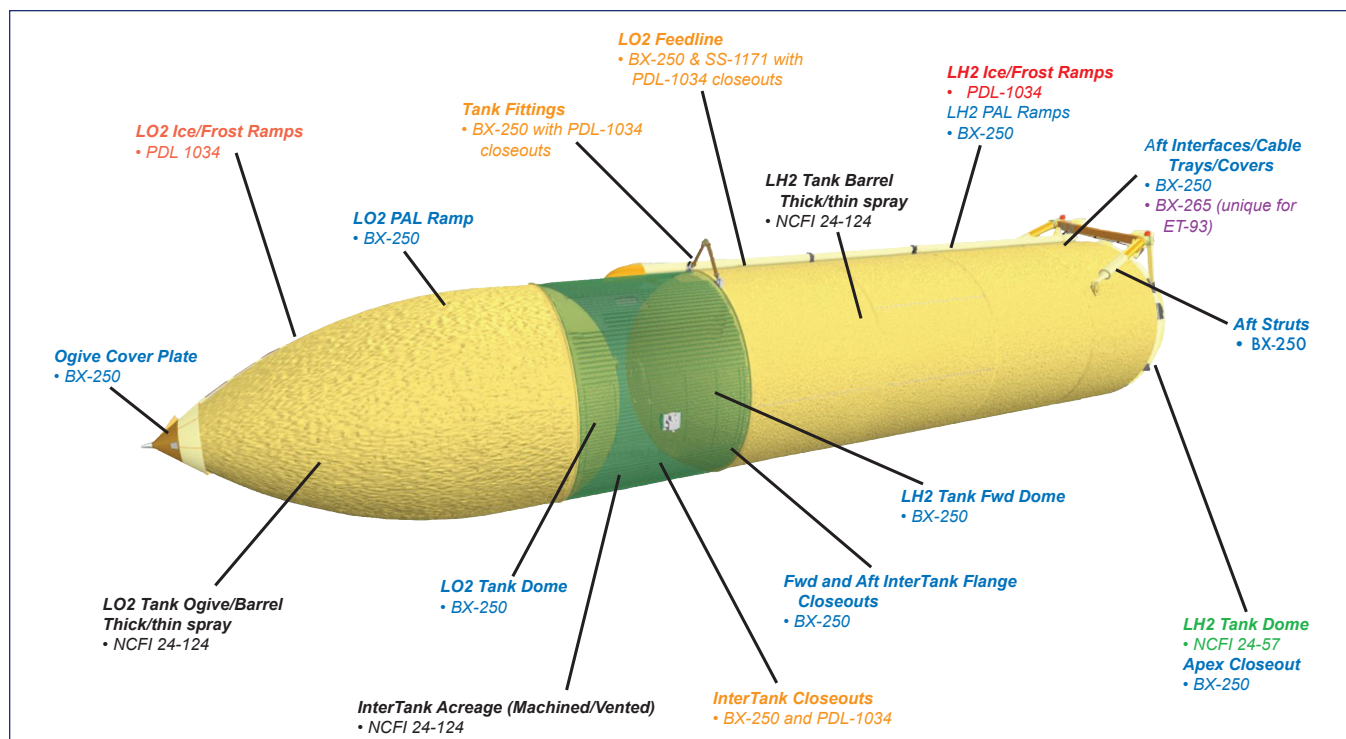
Figure 3.2-4. Locations of the various foam systems as used on ET-93, the External Tank used for STS-107.

oxygen and hydrogen in a liquid state, and to maintain the temperature of external parts high enough to prevent ice and frost from forming on the surface. Figure 3.2-4 summarizes the foam systems used on the External Tank for STS-107.

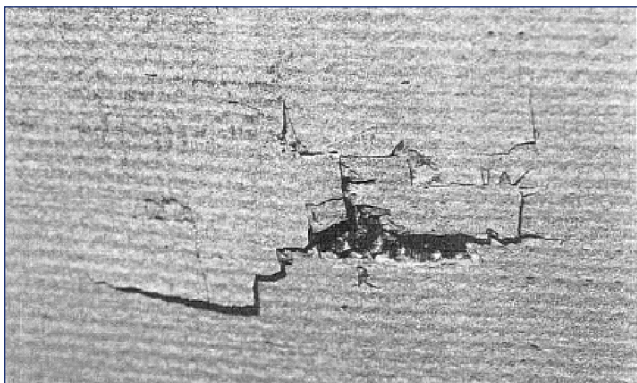
RCC components have been struck by objects throughout their operational life, but none of these components has been completely penetrated. A sampling of 21 post-flight reports noted 43 hypervelocity impacts, the largest being 0.2 inch. The most significant low-velocity impact was to *Atlantis*' panel 10-right during STS-45 in March and April 1992. The damaged area was 1.9 inches by 1.6 inches on the exterior surface and 0.5 inches by 0.1 inches in the interior surface. The substrate was exposed and oxidized, and the panel was scrapped. Analysis concluded that the damage was caused by a strike by a man-made object, possibly during ascent. Figures 3.3-2 and 3.3-3 show the damage to the outer and inner surfaces, respectively.

Figure 3.3-3. Damage on the inner surface of RCC panel 10-right from *Atlantis* after STS-45.

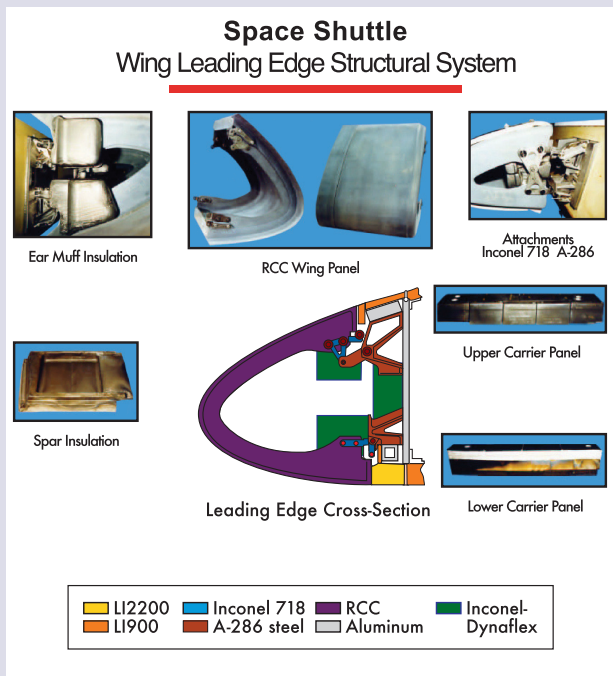
The mid-wing area on the left wing, behind where the breach occurred, is supported by a series of trusses, as shown in red in the figure below. The mid-wing area is bounded in the front and back by the Xo1040 and Xo1191 cross spars, respectively. The numerical designation of each spar comes from its location along the Orbiter's X-axis; for example, the Xo1040 spar is 1,040 inches from the zero point on the X-axis. The cross spars provide the wing's structural integrity. Three major cross spars behind the Xo1191 spar provide the primary structural strength for the aft portion of the wing. The inboard portion of the mid-wing is the outer wall of the left wheel-well, and the outboard portion of the mid-wing is the wing leading edge spar, where the RCC panels attach.

The Wing Leading Edge Structural System on Columbia.

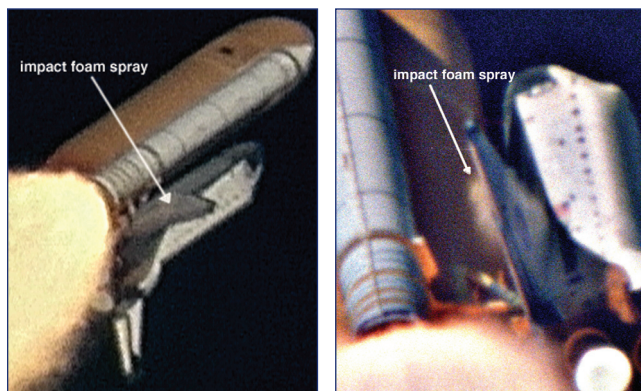
Figure 3.4-1 (color enhanced and "de-blurred" by Lockheed Martin Gaithersburg) and Figure 3.4-2 (processed by the National Imagery and Mapping Agency) are samples of the type of visual data used to establish the time of the impact (81.9 seconds), the altitude at which it occurred (65,860 feet), and the object's relative velocity at impact (about 545 mph relative to the Orbiter).

A 35-mm film camera, E212, which recorded the foam strike from 17 miles away, and video camera E208, which recorded it from 26 miles away, provided the best of the available evidence. Analysis of this visual evidence (see Figures 3.4-1 and 3.4-2) along with computer-aided design analysis, refined the potential impact area to less than 20 square feet in RCC panels 6 through 9 (see Figure 3.4-3), including a portion of the corresponding carrier panels and adjacent tiles. The investigation image analysis team found no conclusive visual evidence of post-impact debris flowing over the top of the wing.

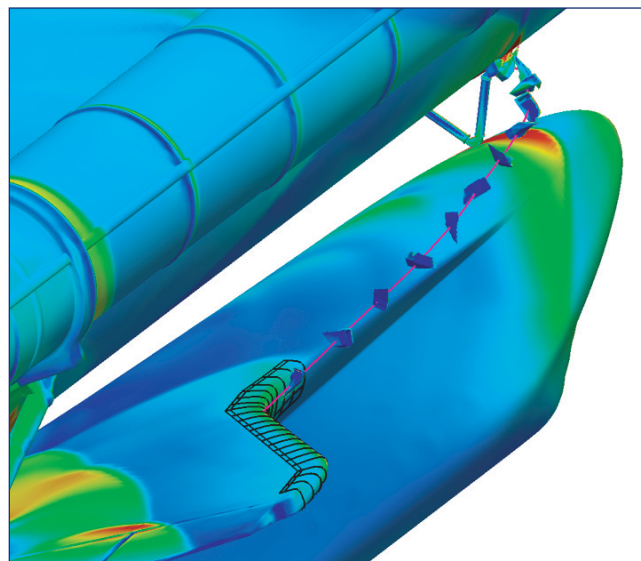
Figure 3.4-6. These are the results of a trajectory analysis that used a computational fluid dynamics approach in a program called CART-3D, a comprehensive (six-degree-of-freedom) computer simulation based on the laws of physics. This analysis used the aerodynamic and mass properties of bipod ramp foam, coupled with the complex flow field during ascent, to determine the likely position and velocity histories of the foam.

The undetermined and yet certainly irregular shape of the foam introduced substantial uncertainty about its estimated aerodynamic characteristics. Appendix D.8 contains an independent analysis conducted by the Board to confirm that the estimated range of ballistic coefficients of the foam in Figure 3.4-6 was credible, given the foam dimension results from the image analyses and the expected range of the foam density. Based on the results in Figure 3.4-7, the physical dimensions of the bipod ramp, and the sizes and shapes of the available barrels for the compressed-gas gun used in the impact test program described later in this chapter, the Board and the NASA Accident Investigation Team decided that a foam projectile 19 inches by 11.5 inches by 5.5 inches, weighing 1.67 pounds, and with a weight density of 2.4 pounds per cubic foot, would best represent the piece of foam that separated from the External Tank bipod ramp and was hit by the Orbiter’s left wing. See Section 3.8 for a full discussion of the foam impact testing.

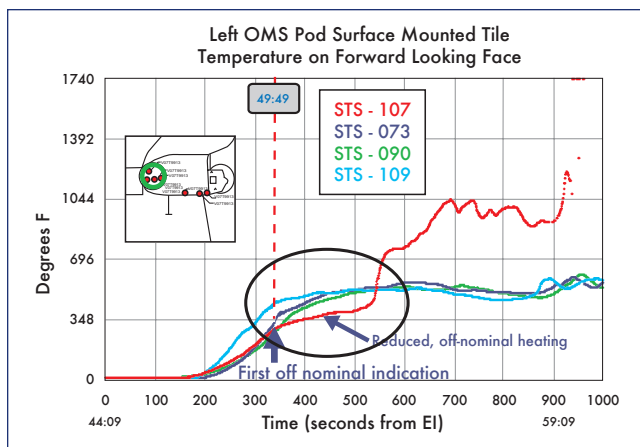
Figure 3.6-9. Orbital Maneuvering System (OMS) pod heating was initially significantly lower than that seen on previous Columbia missions. As wing leading edge damage later increased, the OMS pod heating increased dramatically. Debris recovered from this area of the OMS pod showed substantial pre-breakup heat damage and imbedded drops of once-molten metal from the wing leading edge in the OMS pod thermal tiles.

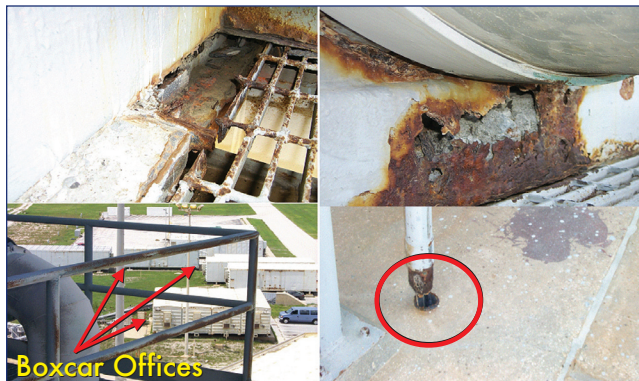
Board investigators have identified deteriorating infrastructure associated with the launch pads, Vehicle Assembly Building, and the crawler transporter. Figures 5.5-5 and 5.5-6 depict some of this deterioration. For example, NASA has installed nets, and even an entire sub-roof, inside the Vehicle Assembly Building to prevent concrete from the building’s ceiling from hitting the Orbiter and Shuttle stack. In addition, the corrosion-control challenge results in zinc primer

on certain launch pad areas being exposed to the elements. When rain falls on these areas, it carries away zinc, runs onto the leading edge of the Orbiter’s wings, and causes pinholes in the Reinforced Carbon-Carbon panels (see Chapter 3).

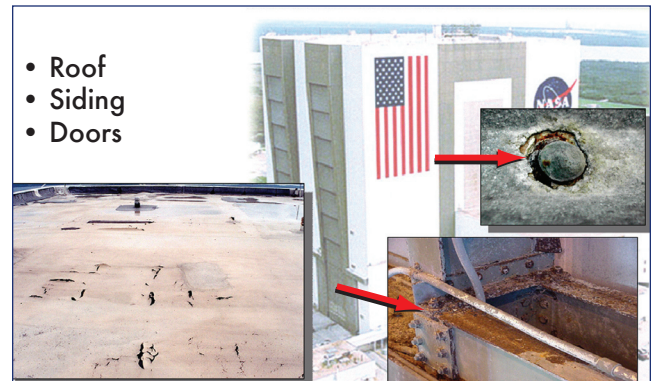
Figure 5.5-5 and 5.5-6. Examples of the seriously deteriorating infrastructure used to support the Space Shuttle Program. At left is Launch Complex 39A, and at right is the Vehicle Assembly building, both at the Kennedy Space Center.

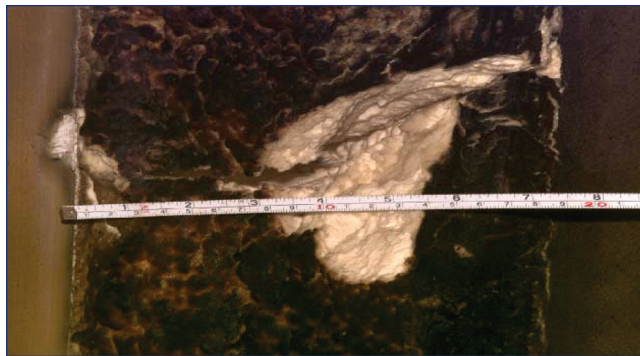
The sixth and final bipod ramp event before STS-107 occurred during STS-112 on October 7, 2002 (see Figure 6.1-3). At 33 seconds after launch, when *Atlantis* was at 12,500 feet and traveling at Mach 0.75, ground cameras observed an object traveling from the External Tank that subsequently impacted the Solid Rocket Booster/External Tank Attachment ring (see Figure 6.1-4). After impact, the debris broke into multiple pieces that fell along the Solid Rocket Booster exhaust plume.¹⁵ Post-mission inspection of the Solid Rocket Booster confirmed damage to foam on the forward face of the External Tank Attachment ring. The impact was approximately 4 inches wide and 3 inches deep. Post-External Tank separation photography by the crew showed that a 4- by 5- by 12-inch (240 cubic-inch) corner section of the left bipod ramp was missing, which exposed the super lightweight ablator coating on the bipod housing. This missing chunk of foam was believed to be the debris that impacted the External Tank Attachment ring during ascent. The post-launch review of photos and video identified these debris events, but the Mission Evaluation Room logs and Mission Management Team minutes do not reflect any discussions of them.

Figure 6.1-4. On STS-112, the foam impacted the External Tank Attach ring on the Solid Rocket Booster, causing this tear in the insulation on the ring.

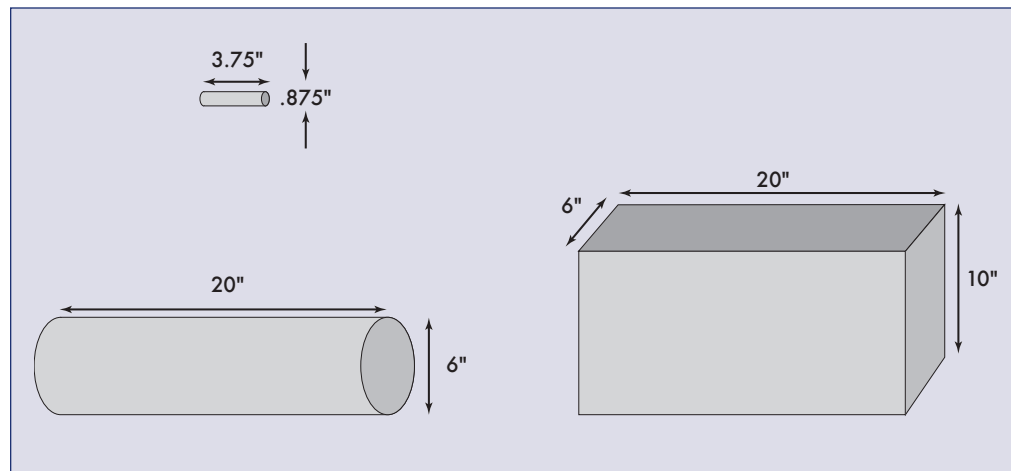
Until STS-107, Crater was normally used only to predict whether small debris, usually ice on the External Tank, would pose a threat to the Orbiter during launch. The use of Crater to assess the damage caused by foam during the launch of STS-107 was the first use of the model while a mission was on orbit. Also of note is that engineers used Crater during STS-107 to analyze a piece of debris that was at maximum 640 times larger in volume than the pieces of debris used to calibrate and validate the Crater model (the Board’s best estimate is that it actually was 400 times larger). Therefore, the use of Crater in this new and very different situation compromised NASA’s ability to accurately predict debris damage in ways that Debris Assessment Team engineers did not fully comprehend (see Figure 6.3-1).

Figure 6.3-1. The small cylinder at top illustrates the size of debris Crater was intended to analyze. The larger cylinder was used for the STS-107 analysis; the block at right is the estimated size of the foam.

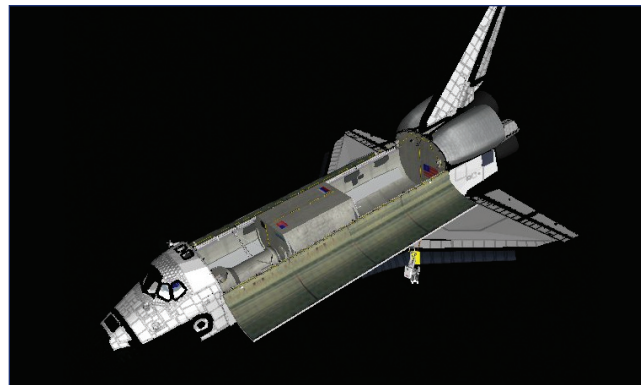
Figure 6.4-1. The speculative repair option would have sent astronauts hanging over the payload bay door to reach the left wing RCC panels using a ladder scavenged from the crew module.

The repair option (see Figure 6.4-1), while logistically viable using existing materials onboard *Columbia*, relied on so many uncertainties that NASA rated this option "high risk." To complete a repair, the crew would perform a spacewalk to fill an assumed 6-inch hole in an RCC panel with heavy metal tools, small pieces of titanium, or other metal scavenged from the crew cabin. These heavy metals, which would help protect the wing structure, would be held in place during

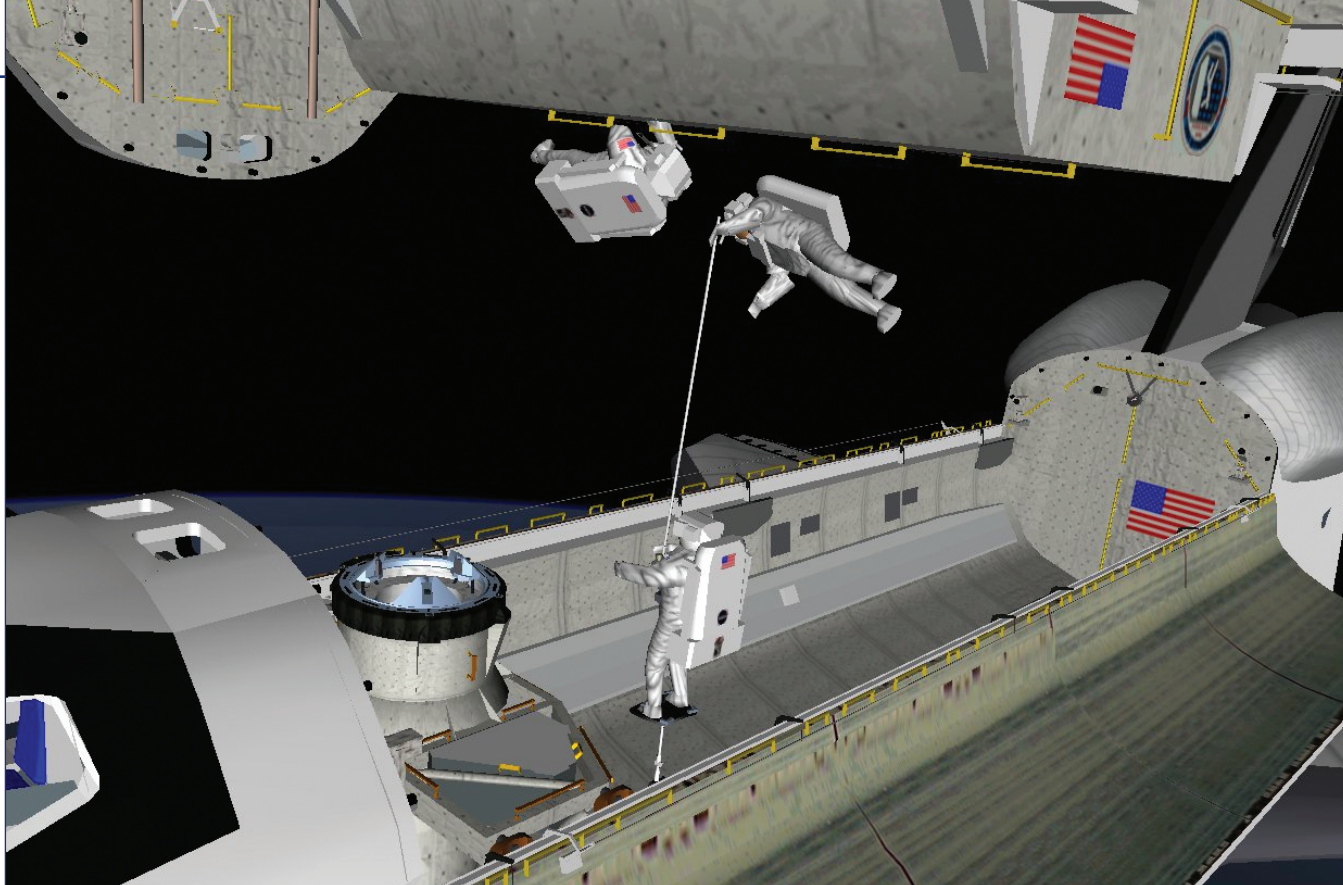
Figure 6.4-2. The rescue option had Atlantis (lower vehicle) rendezvousing with Columbia and the STS-107 crew transferring via ropes. Note that the payload bay of Atlantis is empty except for the external airlock/docking adapter.

er, pilot, and two astronauts trained for spacewalks. In January, seven commanders, seven pilots, and nine spacewalk-trained astronauts were available. During the rendezvous on *Atlantis*'s first day in orbit, the two Orbiters would maneuver to face each other with their payload bay doors open (see Figure 6.4-2). Suited *Columbia* crew members would then be transferred to *Atlantis* via spacewalks. *Atlantis* would return with four crew members on the flight deck and seven in the mid-deck. Mission Control would then configure *Columbia* for a de-orbit burn that would ditch the Orbiter in the Pacific Ocean, or would have the *Columbia* crew take it to a higher orbit for a possible subsequent repair mission if more thorough repairs could be developed.

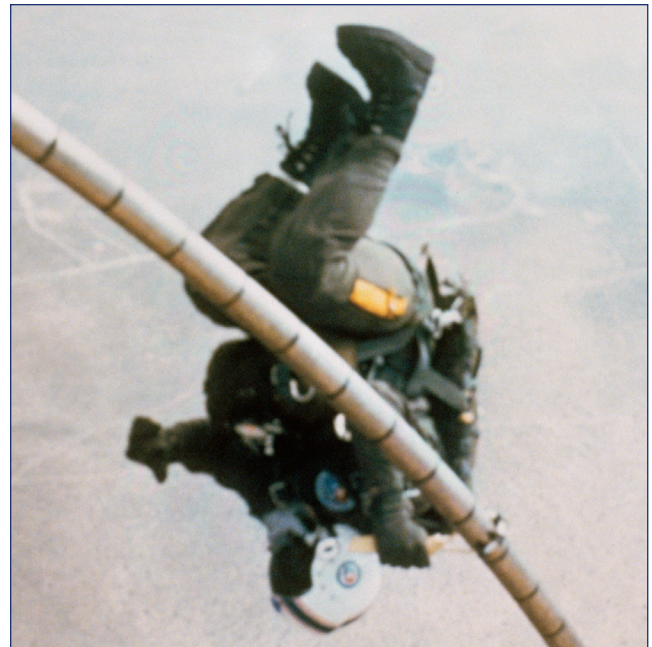
In response to this recommendation, NASA developed the current “pole bailout” system for use during controlled, subsonic gliding flight (see Figure 10.2-1). The system requires crew members to “vent” the cabin at 40,000 feet (to equalize the cabin pressure with the pressure at that altitude), jettison the hatch at approximately 32,000 feet, and then jump out of the vehicle (the pole allows crew members to avoid striking the Orbiter’s wings).

Figure 10.2-1. A demonstration of the pole bailout system. The pole is extending from the side of a C-141 simulating the Orbiter, with a crew member sliding down the pole so that he would fall clear of the Orbiter’s wing during an actual bailout.

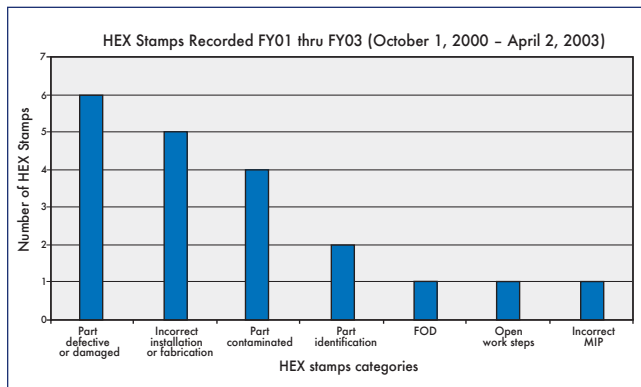
Of the 141,127 inspections subject to rejection from October 2000 through March 2003, only 20 rejections, or "hexes," were recorded, resulting in a statistically improbable discrepancy rate of .014 percent (see Figure 10.4-4). In interviews, technicians and inspectors alike confirmed the dubiousness of this rate. NASA's published rejection rate therefore indicates either inadequate documentation or an underused system. Testimony further revealed incidents of quality assurance inspectors being played against each other to accept work that had originally been refused.

Figure 10.4-4. Rejection, or "Hex" stamps issued from October 2000 through April 2003.
