# STS-1 Orbiter Final Mission Report

August 1981

**Lyndon B. Johnson Space Center**  
Houston, Texas

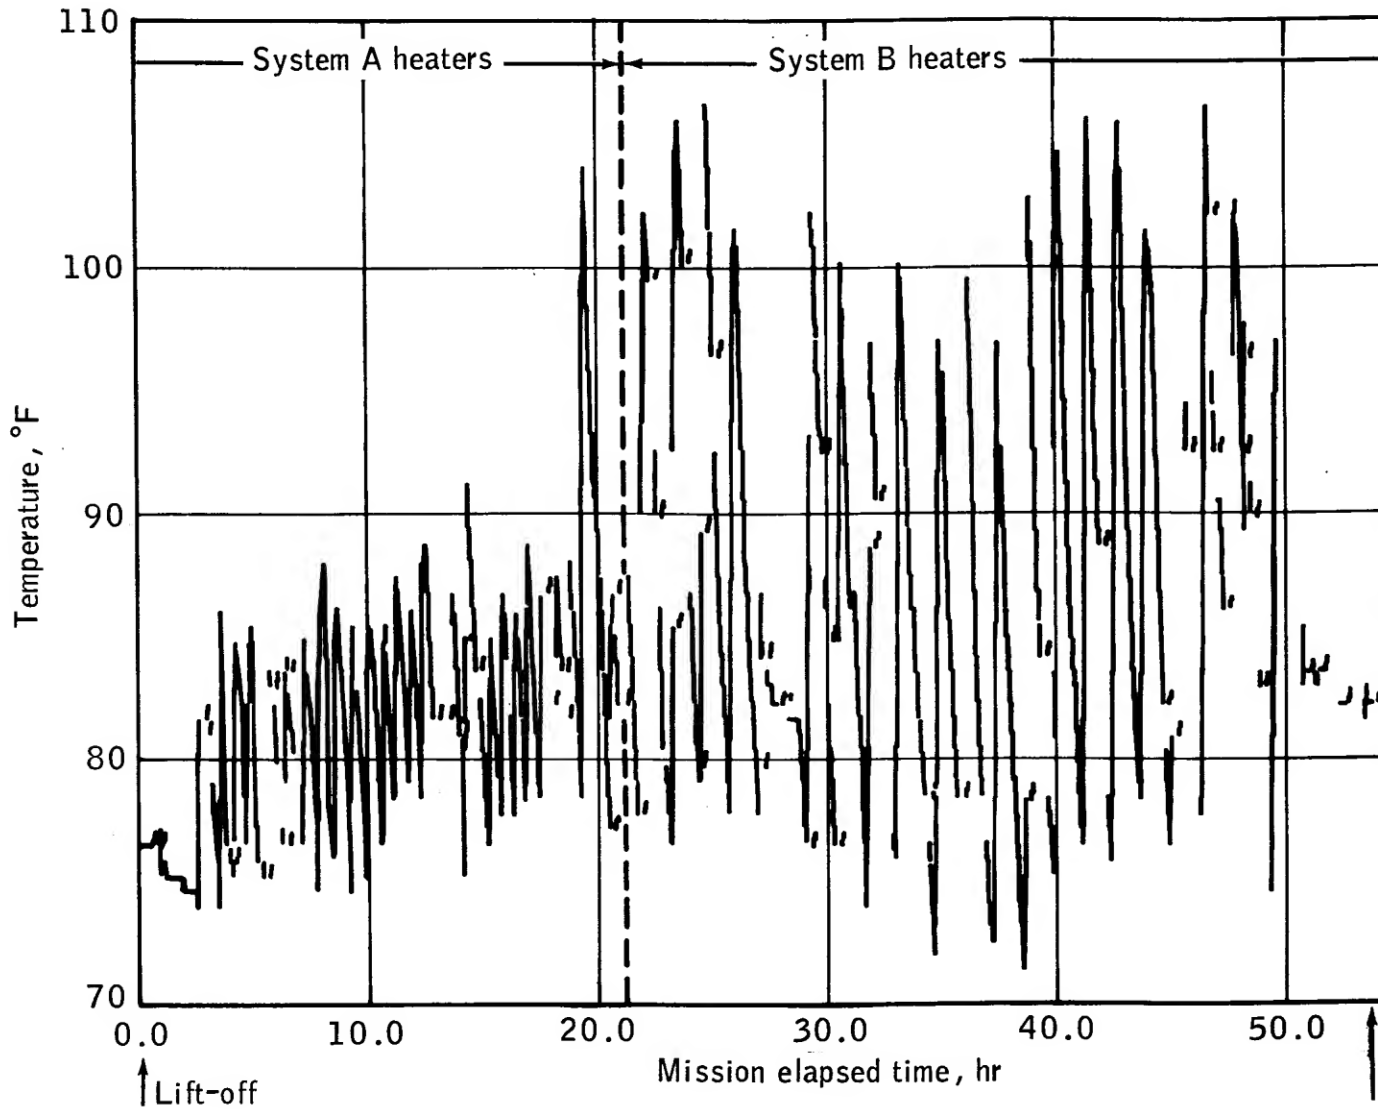
Figure 2-17.- Flash evaporator feed line temperature amplitude change.

At 103:09:30 G.m.t., the FES feed water line heaters on the port side were switched from system A heaters to system B heaters, the switch resulting in a temperature amplitude change (figure 2-17). Mislocation of the temperature transducer is suspected.

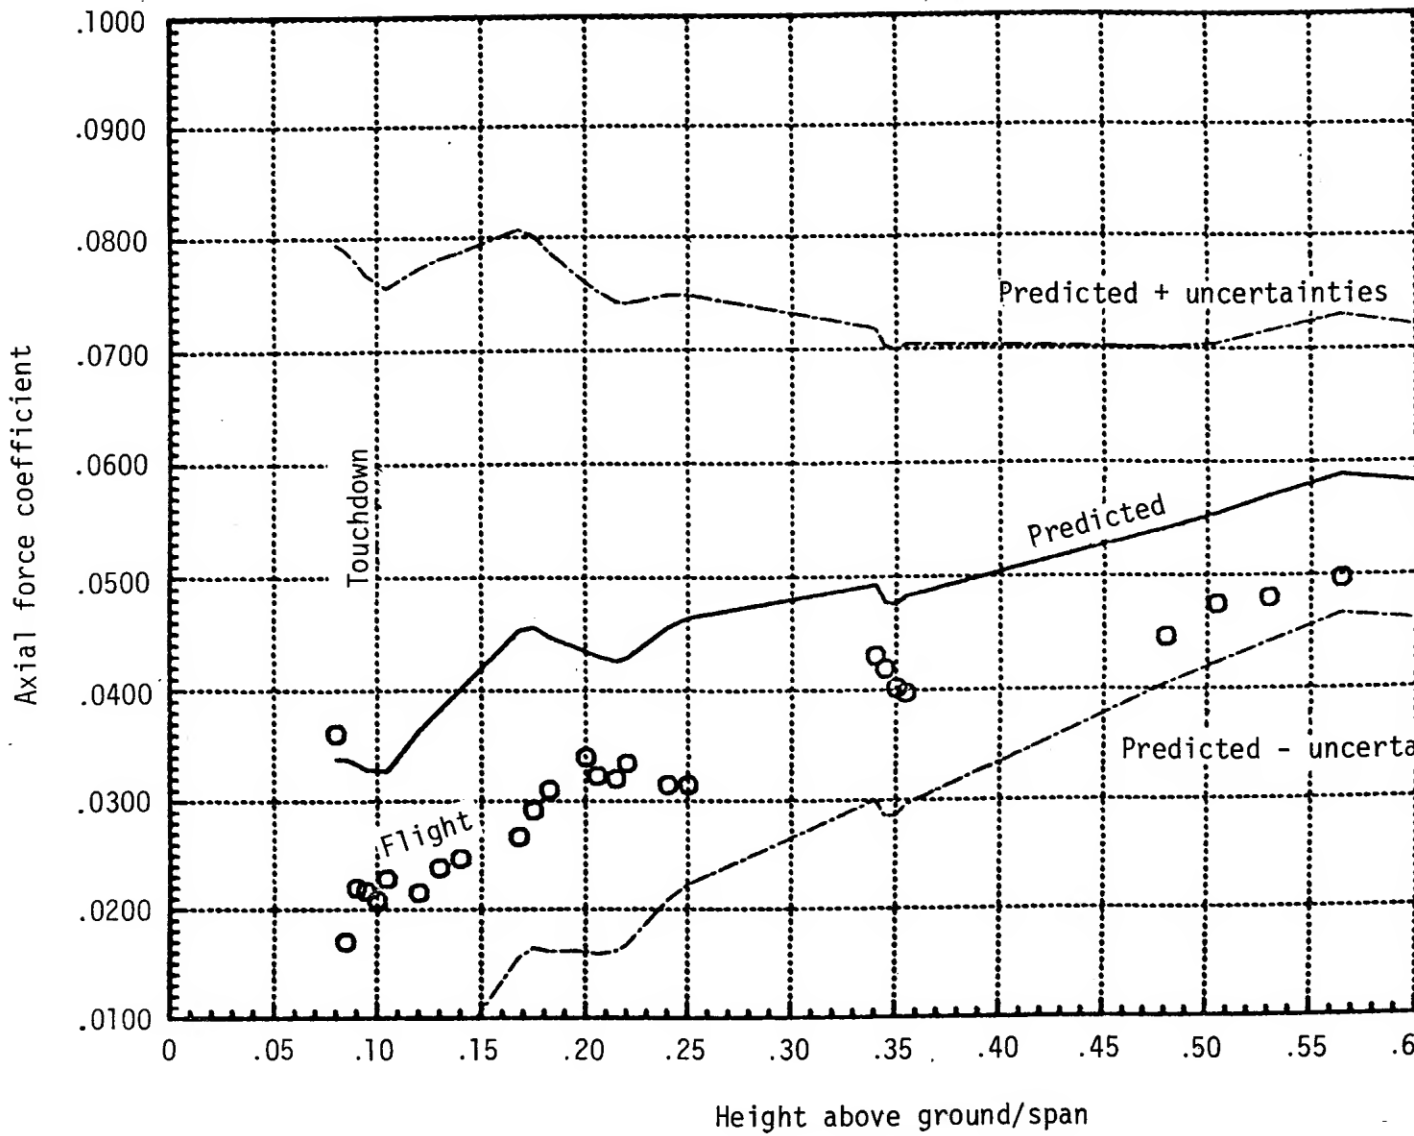
Figure 2-31.- Lower than predicted axial force coefficient during landing.

2.9.2.1 Performance and Trim. - Comparisons of the predicted lift-to-drag (L/D) ratio and the predicted  $\pm$  uncertainties data with the calculated STS-1 L/D ratio are shown in figure 2-30. There was no discernable difference between the predicted and actual calculated values down the last 100 ft before touchdown. At that point, ground effects occurred which caused the L/D to be higher than predicted. This difference was traced to the axial force coefficient that was lower than predicted (fig. 2-31).

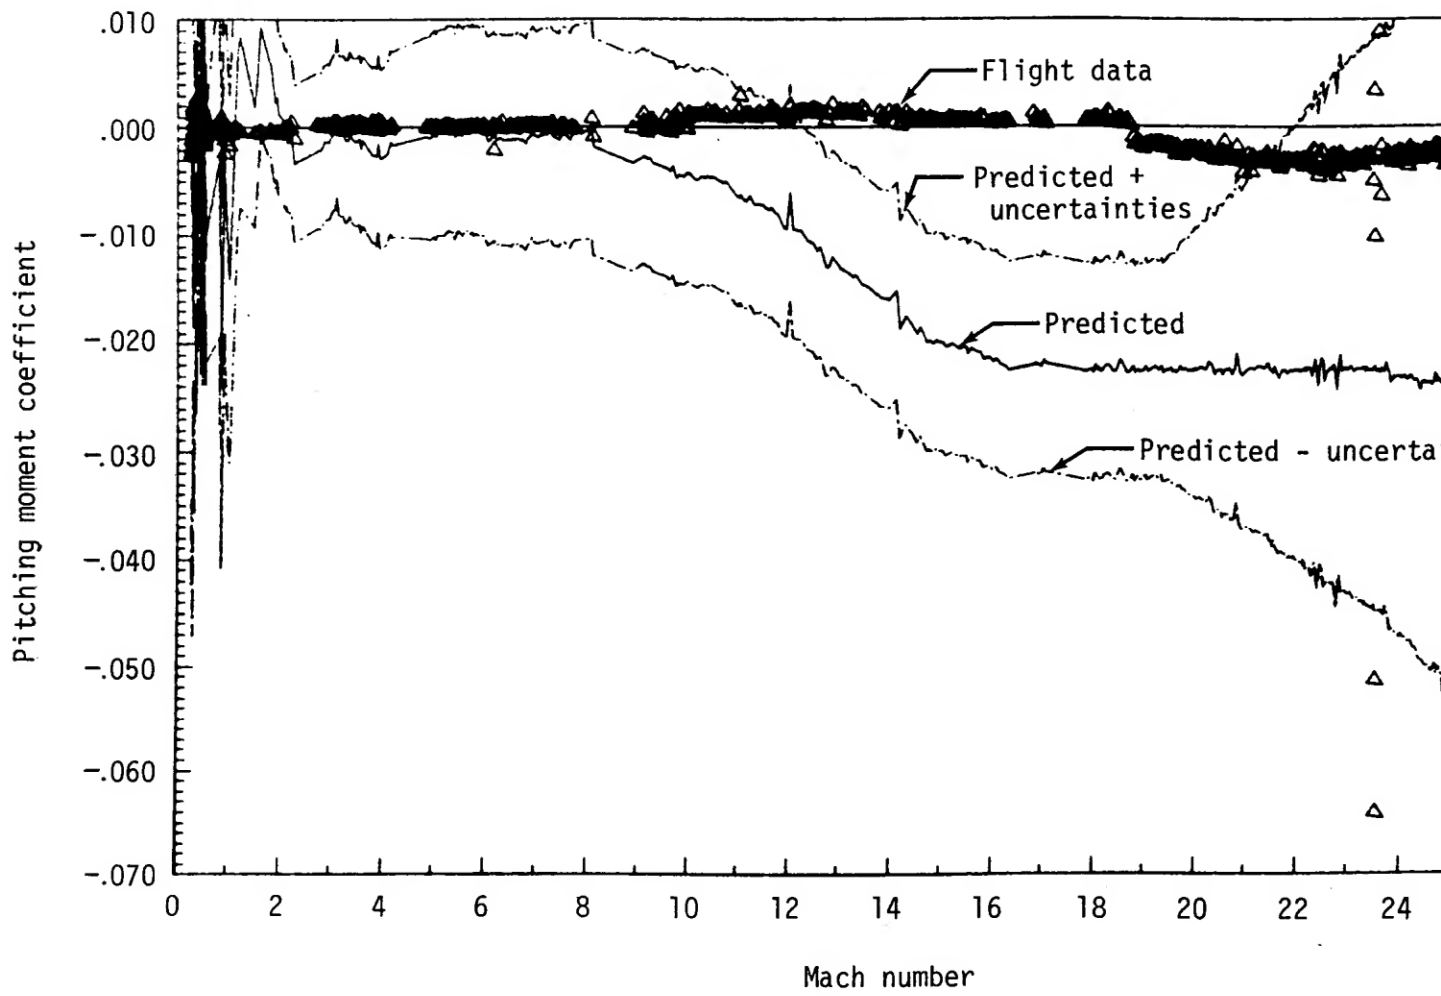
Figure 2-32.- Pitching moment coefficient during entry phase.

The body flap functioned as predicted except at the higher Mach numbers (28 to 8) where the body flap was down 7 degrees further than predicted. Between Mach 21 and 12, the pitching moment coefficient flight values fall outside the predicted and uncertainties bank (fig. 2-32) (Section 8.0, flight test problem report 39). Below Mach 8, the pitching moment coefficient followed the predicted value.

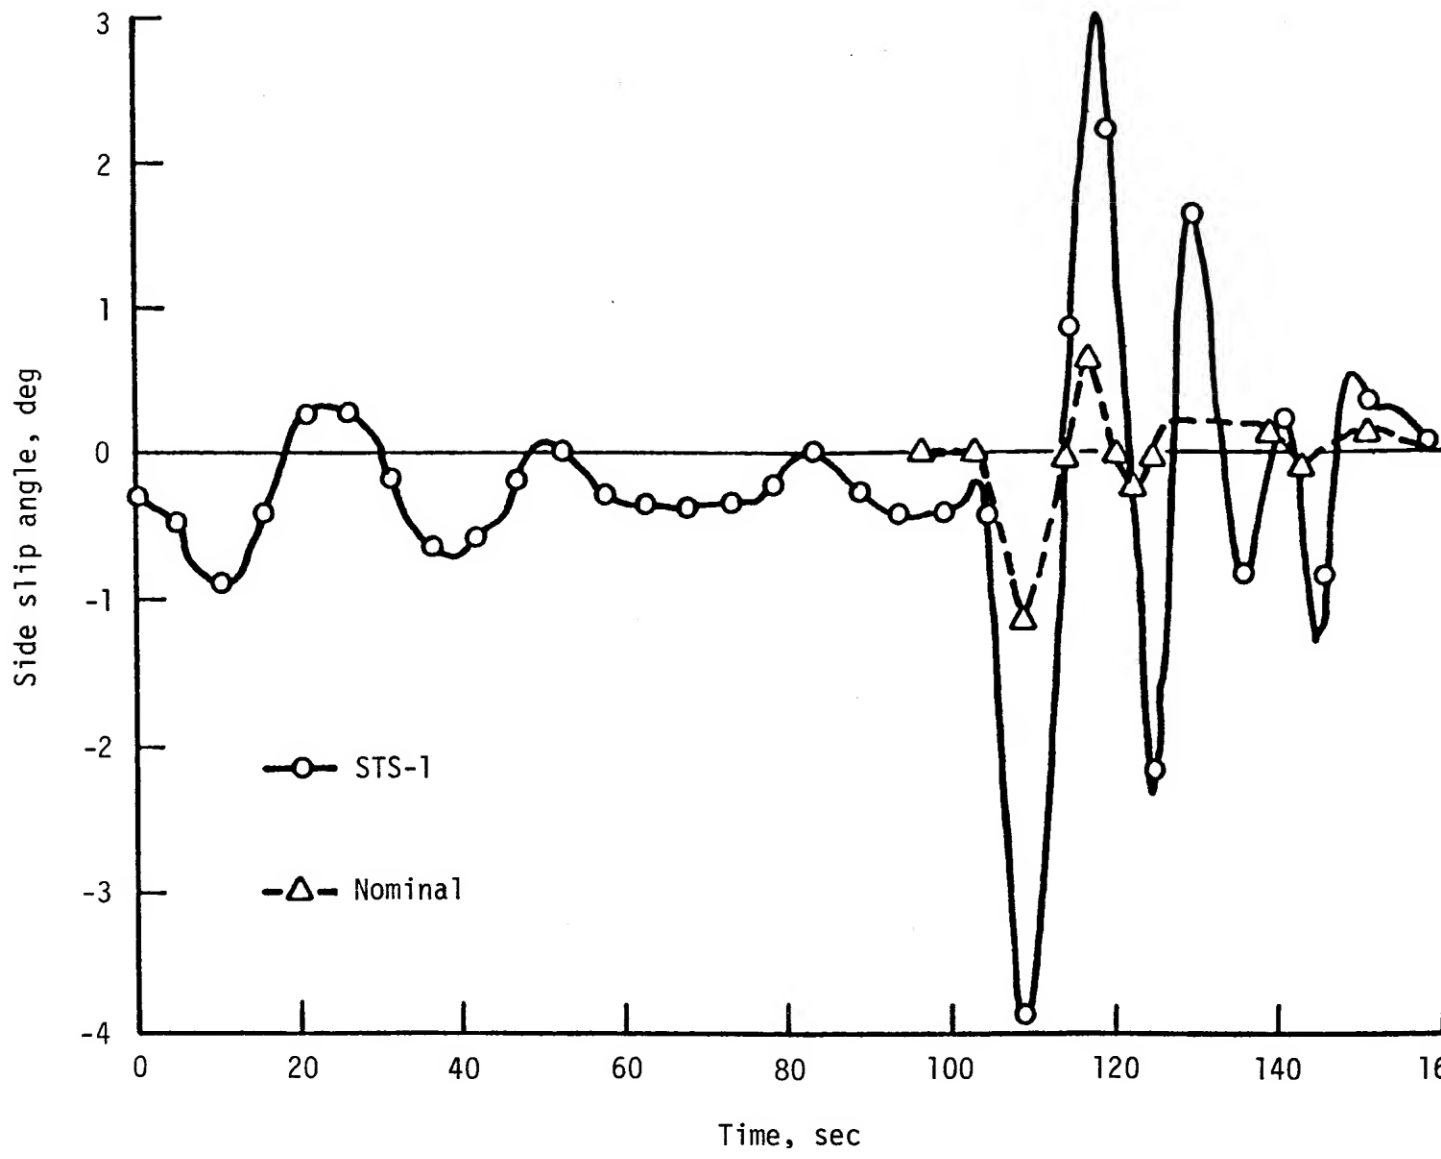
Figure 2-33.- Oscillations from first bank reversal.

2.9.2.2 Bank Reversals. - The initial bank reversal was performed at a dynamic pressure of 14 lb/ft. This reversal created several cycles of lightly damped motion that resulted in peak beta values of 4 degrees (fig. 2-33). Analysis and motion matching studies have shown that this discrepancy resulted from the rolling moment from the yaw thrusters. The predictions had this roll moment included, but at a higher level (fig. 2-34).

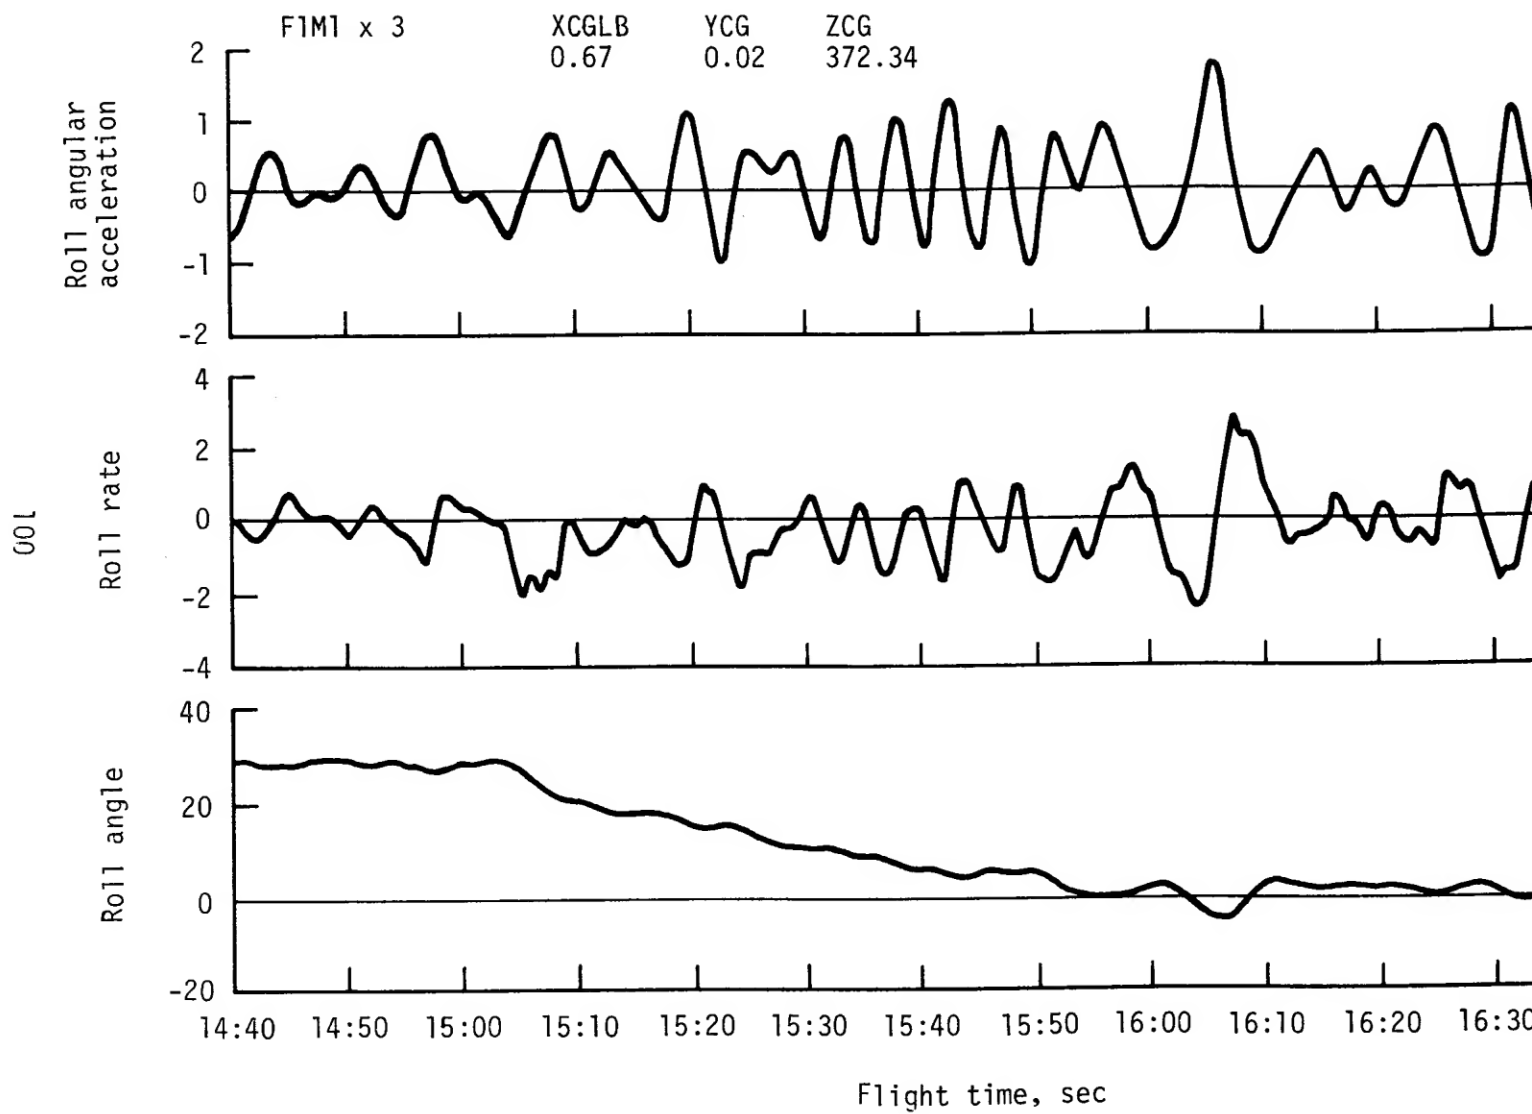
Figure 2-37.- Transonic undamped low frequency oscillations.

2.9.2.3 Transonic Oscillation. - Figure 2-37 shows an undamped low frequency oscillation that was apparent during the Mach 2 to Mach 1 region. Motion matching studies using optimization programs were attempted, but repeatable stability and control derivatives could not be obtained. Consequently, specially designed maneuvers will be conducted and STS-2 to more clearly identify the coefficients.

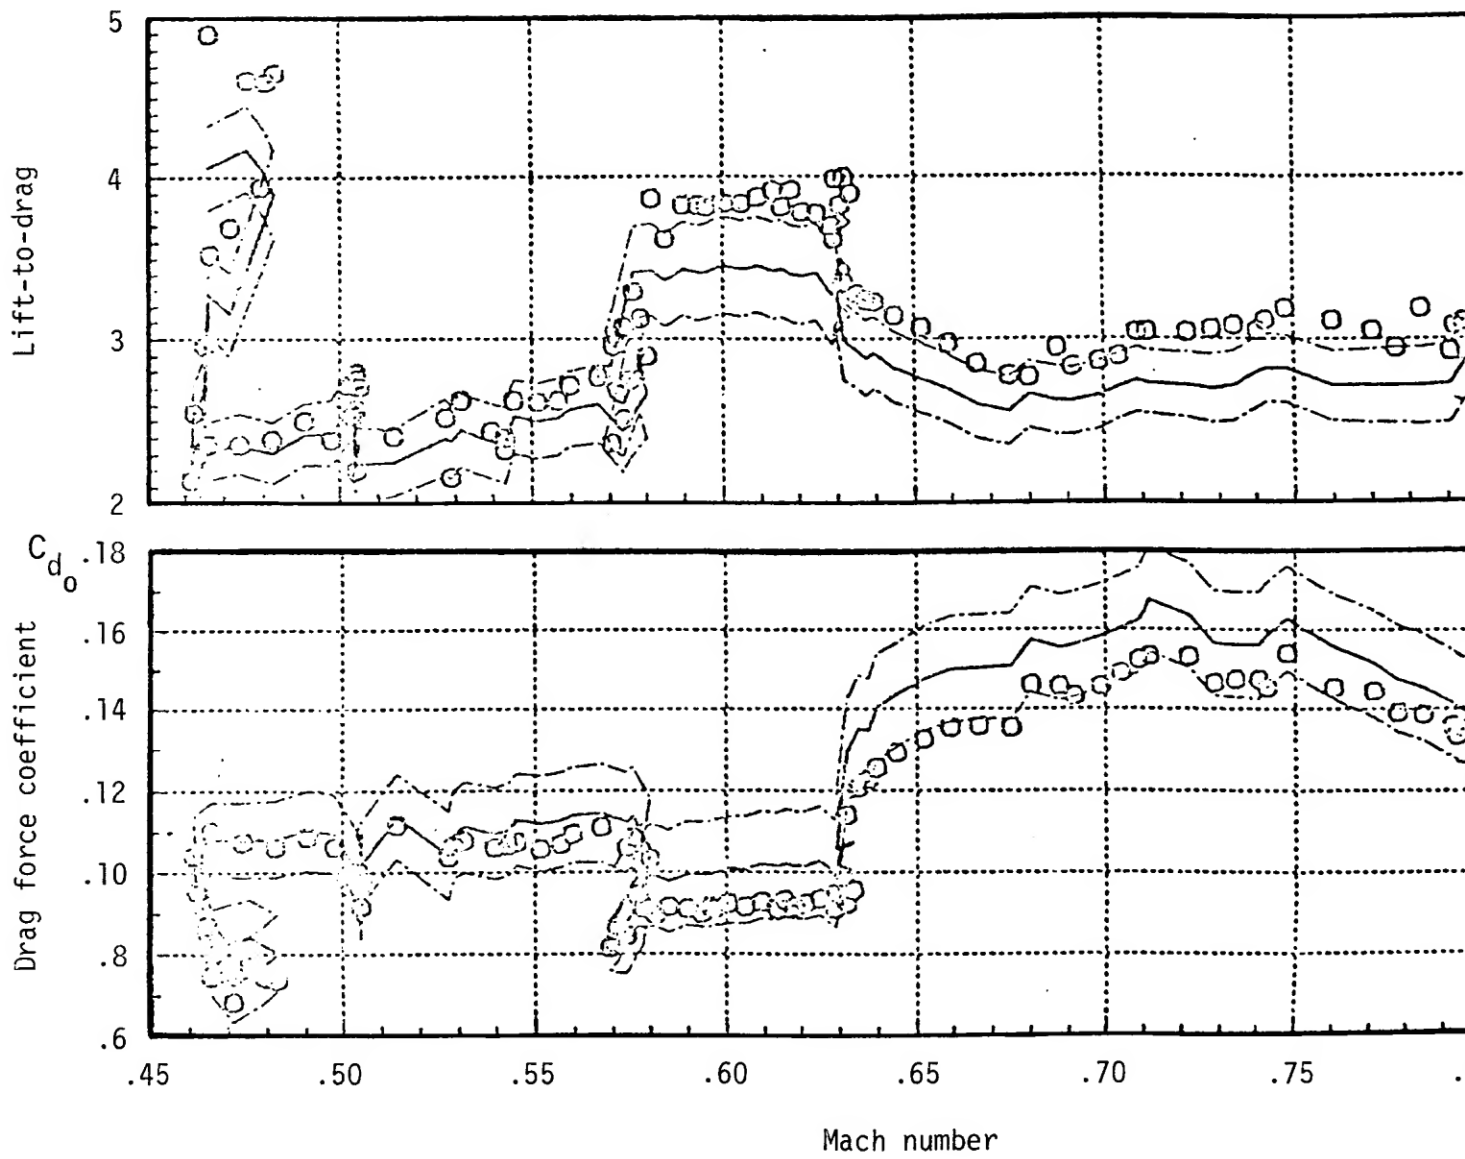
Figure 2-38.- Drag force coefficient and lift-to-drag ratio.

2.9.2.4 Approach and Landing. - An evaluation of the aerodynamics during the approach and landing phase showed differences from the preflight predictions in both the drag force coefficient (fig. 2-38) and the speedbrake drag (fig. 2-39). The difference along with the increased L/D discussed previously, contributed approximately 1000 ft of the 3200 ft landing point overshoot.

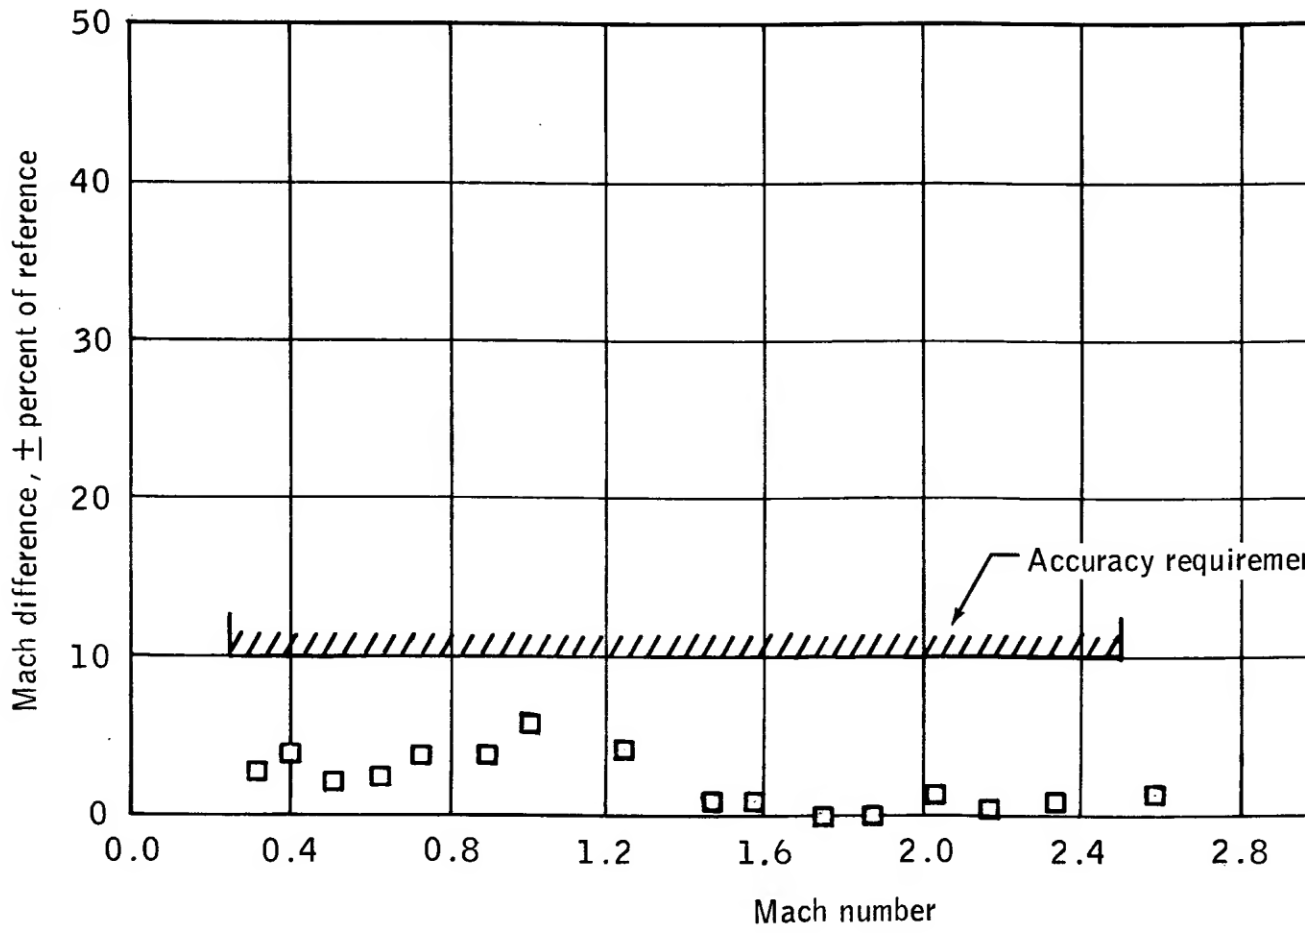
Figure 2-40.- Quick-look analysis of air data system accuracy for mach nu

A preliminary analysis to determine whether the calibrations provided air data that satisfied operational accuracy requirements has been performed. This analysis used onboard velocities and landing site touchdown +5 hour atmospheric data to develop reference air data which are then compared to the side probe data. The difference is compared to operational accuracy requirements. The results of this analysis are presented in figures 2-40 through 2-43, where comparisons for Mach number, angle-of-attack, dynamic pressure, and velocity are made. On the basis of these comparisons, the conclusion is that the air data probe wind tunnel calibrations provided air data parameters within operational accuracy requirements.

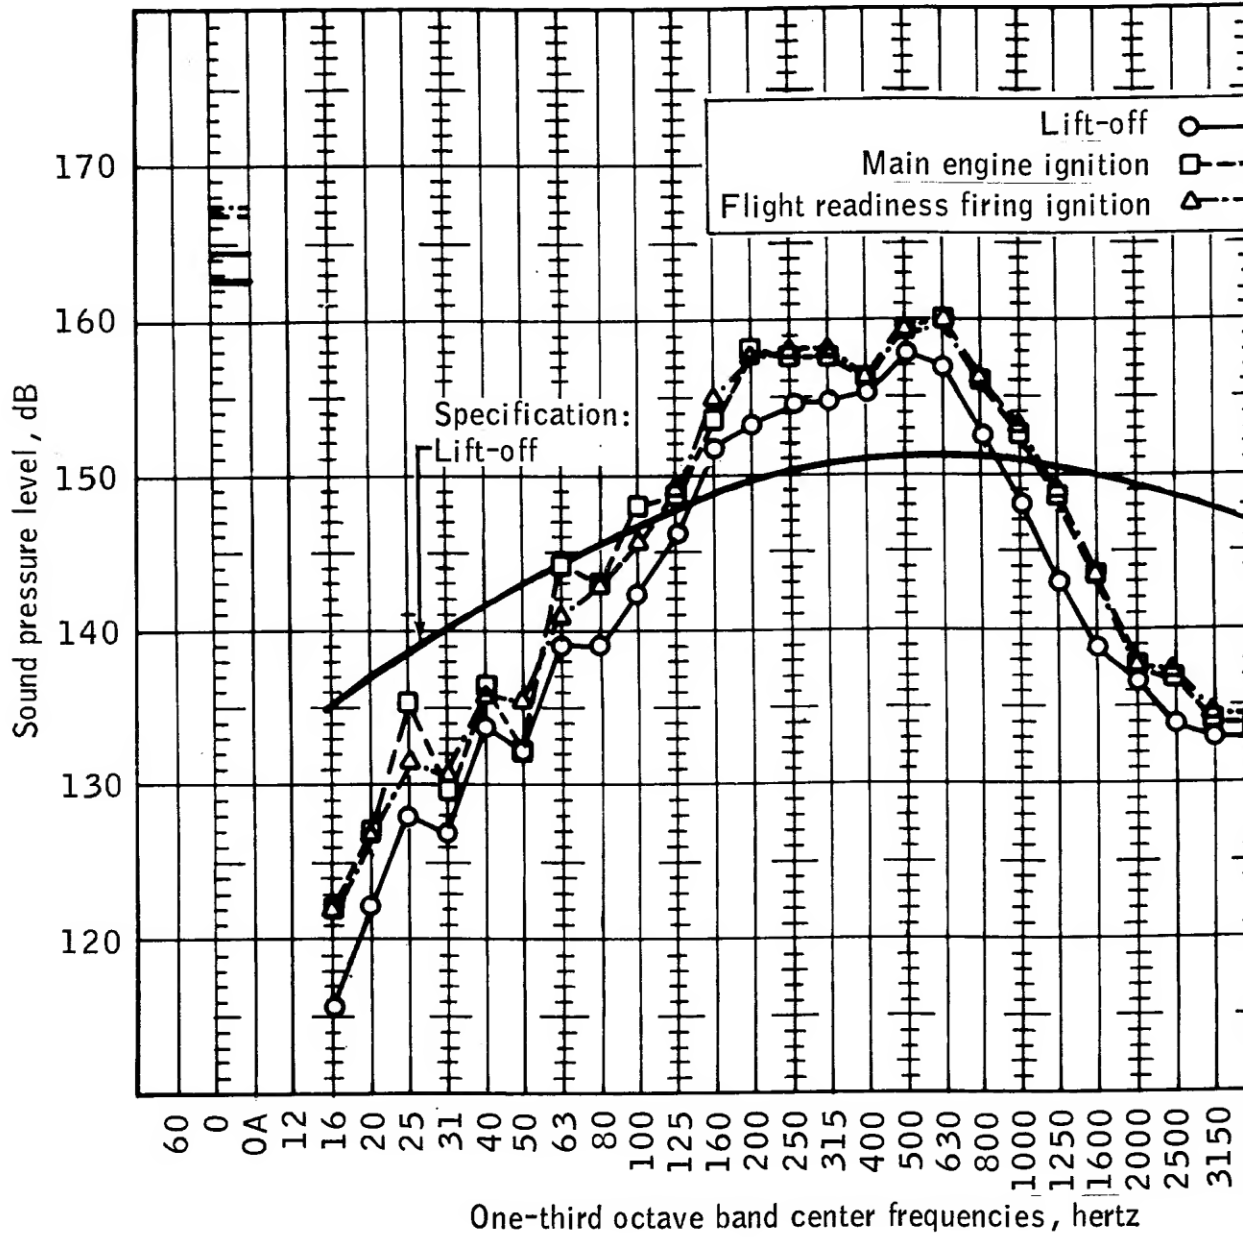
Figure 3-1.- Comparison of launch phase. Noise level at the tip of the vertical

Acoustical data measured on the Orbiter active transducers were reviewed for compliance with the design specification criteria. Data were reviewed for the time period from main engine start through the supersonic phase of ascent and for the entry phase of maximum dynamic pressure. The measured data were within specification with the exception of two areas; i.e., the top of the body flap and the tip of the vertical tail. These two areas were also above specification during the flight readiness firing. Figures 3-1 and 3-2 show a comparison of the noise levels measured for these two areas during STS-1 lift-off and during the flight readiness firing. After the firing and prior to STS-1, a detailed evaluation of the structure and the thermal protection system (TPS) loading in these areas showed no constraints for STS-1, and since the STS-1 and flight readiness firing levels are about the same, no constraints apply to STS-2.

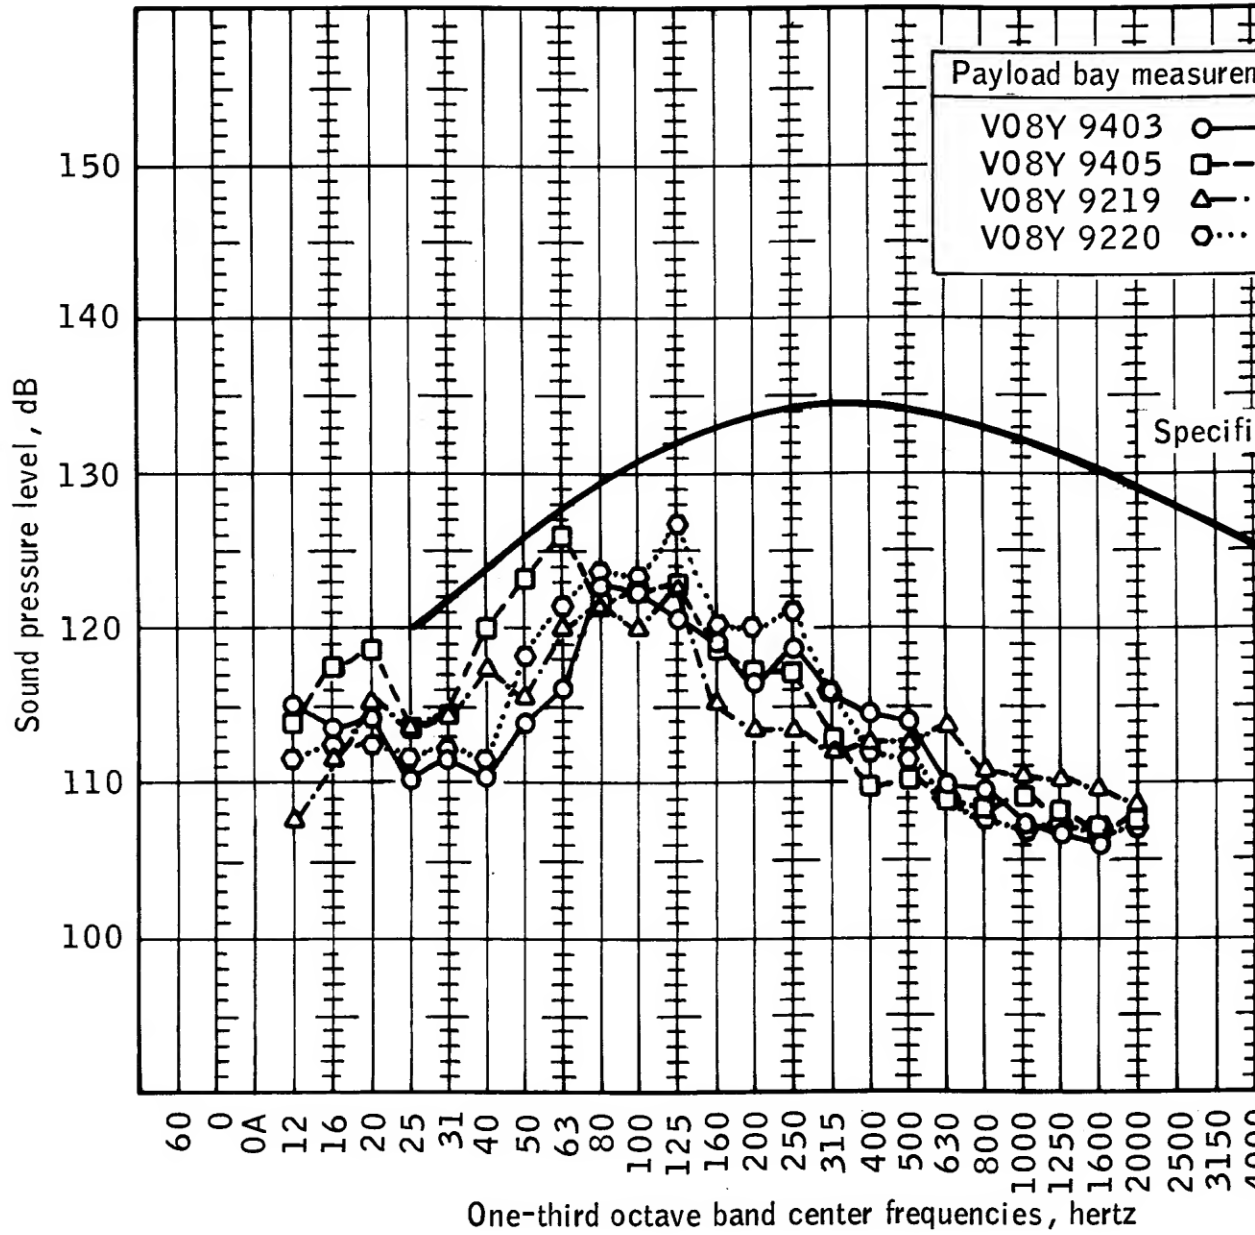
Figure 3-3.- Internal acoustic measurements from payload bay at main engine :

The plots in figures 3-3, 3-4, and 3-5 are one-third octave bands representing the frequencies of 12.5 to 2000 Hz for analyzing averaging time of 1.0 second. In the frequency range from 12.5 to 80 Hz, the measured noise level is in agreement with the specification curve. From the 80 Hz to 2000 Hz the attenuation of the noise level was greater than predicted. The variance from the specification is around 5-8 dB at the midfrequency and reaches as much as 15-19 dB at the extreme upper frequency. The overall dB level for the four internal microphones ranged from 130 to 133.5 as compared to the 145 dB for the specification criteria overall. Figure 3-6 is a space average plot of the four internal microphones for the SSME ignition and SRB ignition/lift-off event times. The space averaging takes into consideration the influence of any microphone that may be reading high or low relative to the other microphones. The overall dB levels of 133 and 130 for each time event are still below the specification criteria.

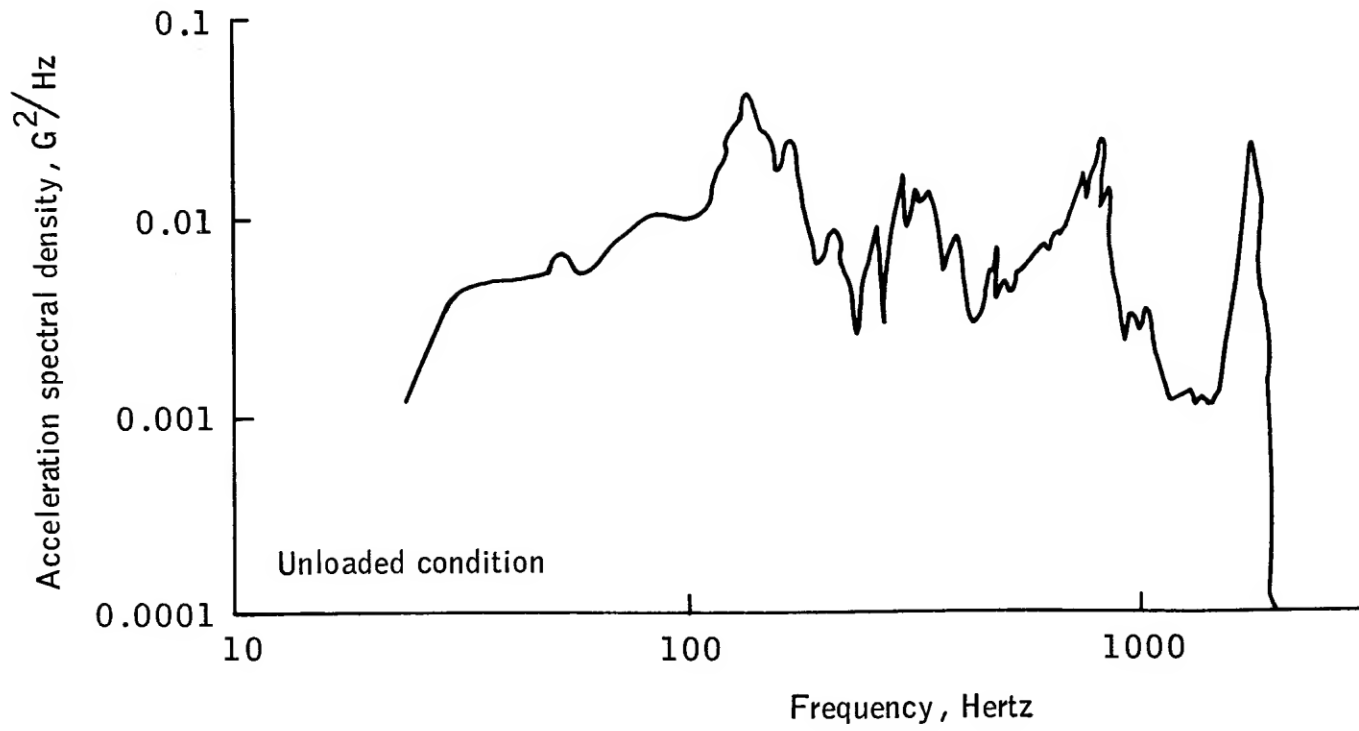
Figure 3-7. - Payload bay random vibration data for envelope of 12 measurements

Vibration data analyzed from the STS-1 mission were obtained from 12 high-frequency transducers located on the main longeron, keel, and trunnion areas. The vibration was analyzed in the frequency band of 20 to 2500 Hz at an analysis bandwidth of 2 Hz and 10 Hz. Acceleration spectral density plots were made for the same event times as the acoustics. Figure 3-7 is an envelope of the 12 measurements. The envelope represents the highest peaks of the measured level for the transducers for all the event times.
