# Analysis of Possible Explosions at Kennedy Space Center

## Due to Spontaneous Ignition of Hypergolic Propellants

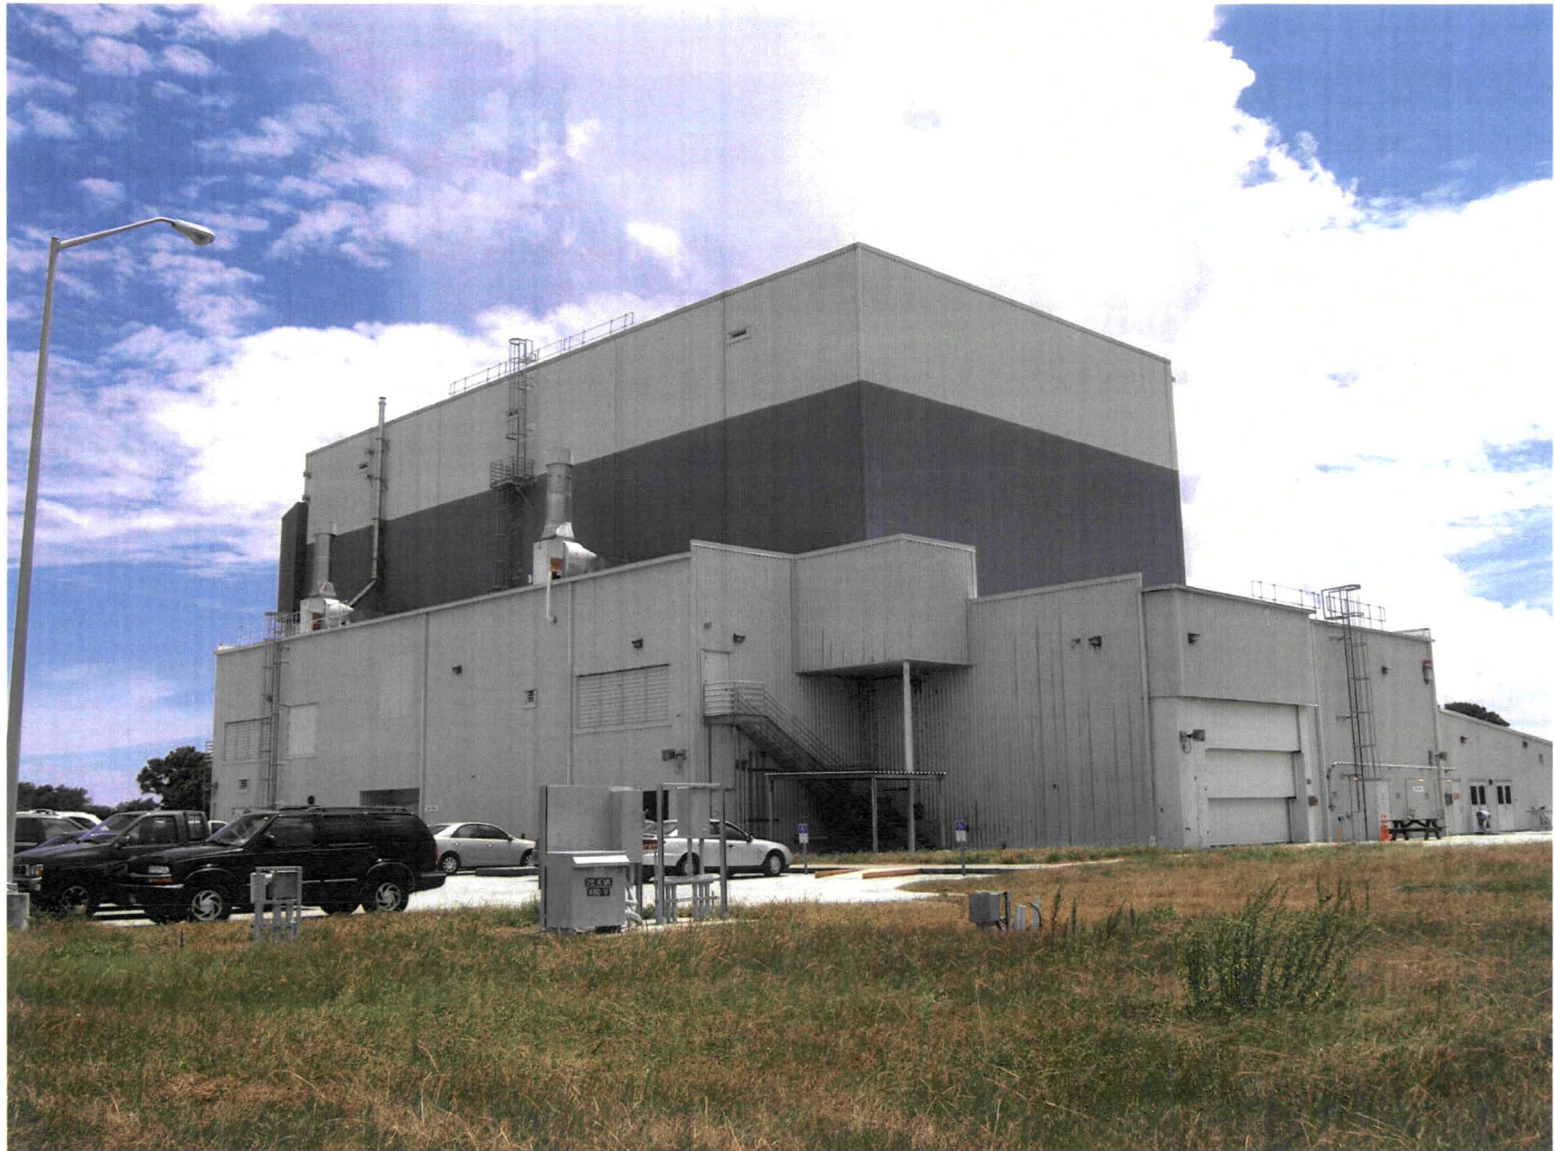
Figure 1. Multi-Payload Processing Facility (MPPF)

Subsequent discussion deals with the MPPF analysis. Figure 1 provides a view of the MPPF from the northwest. An interior view of the facility is shown in Figure 2. The study was concerned with both blast hazards and hazardous fragments which exceed existing safety standards, as described in Section 2.0. The analysis included both blast and fragmentation effects and was divided into three parts as follows:

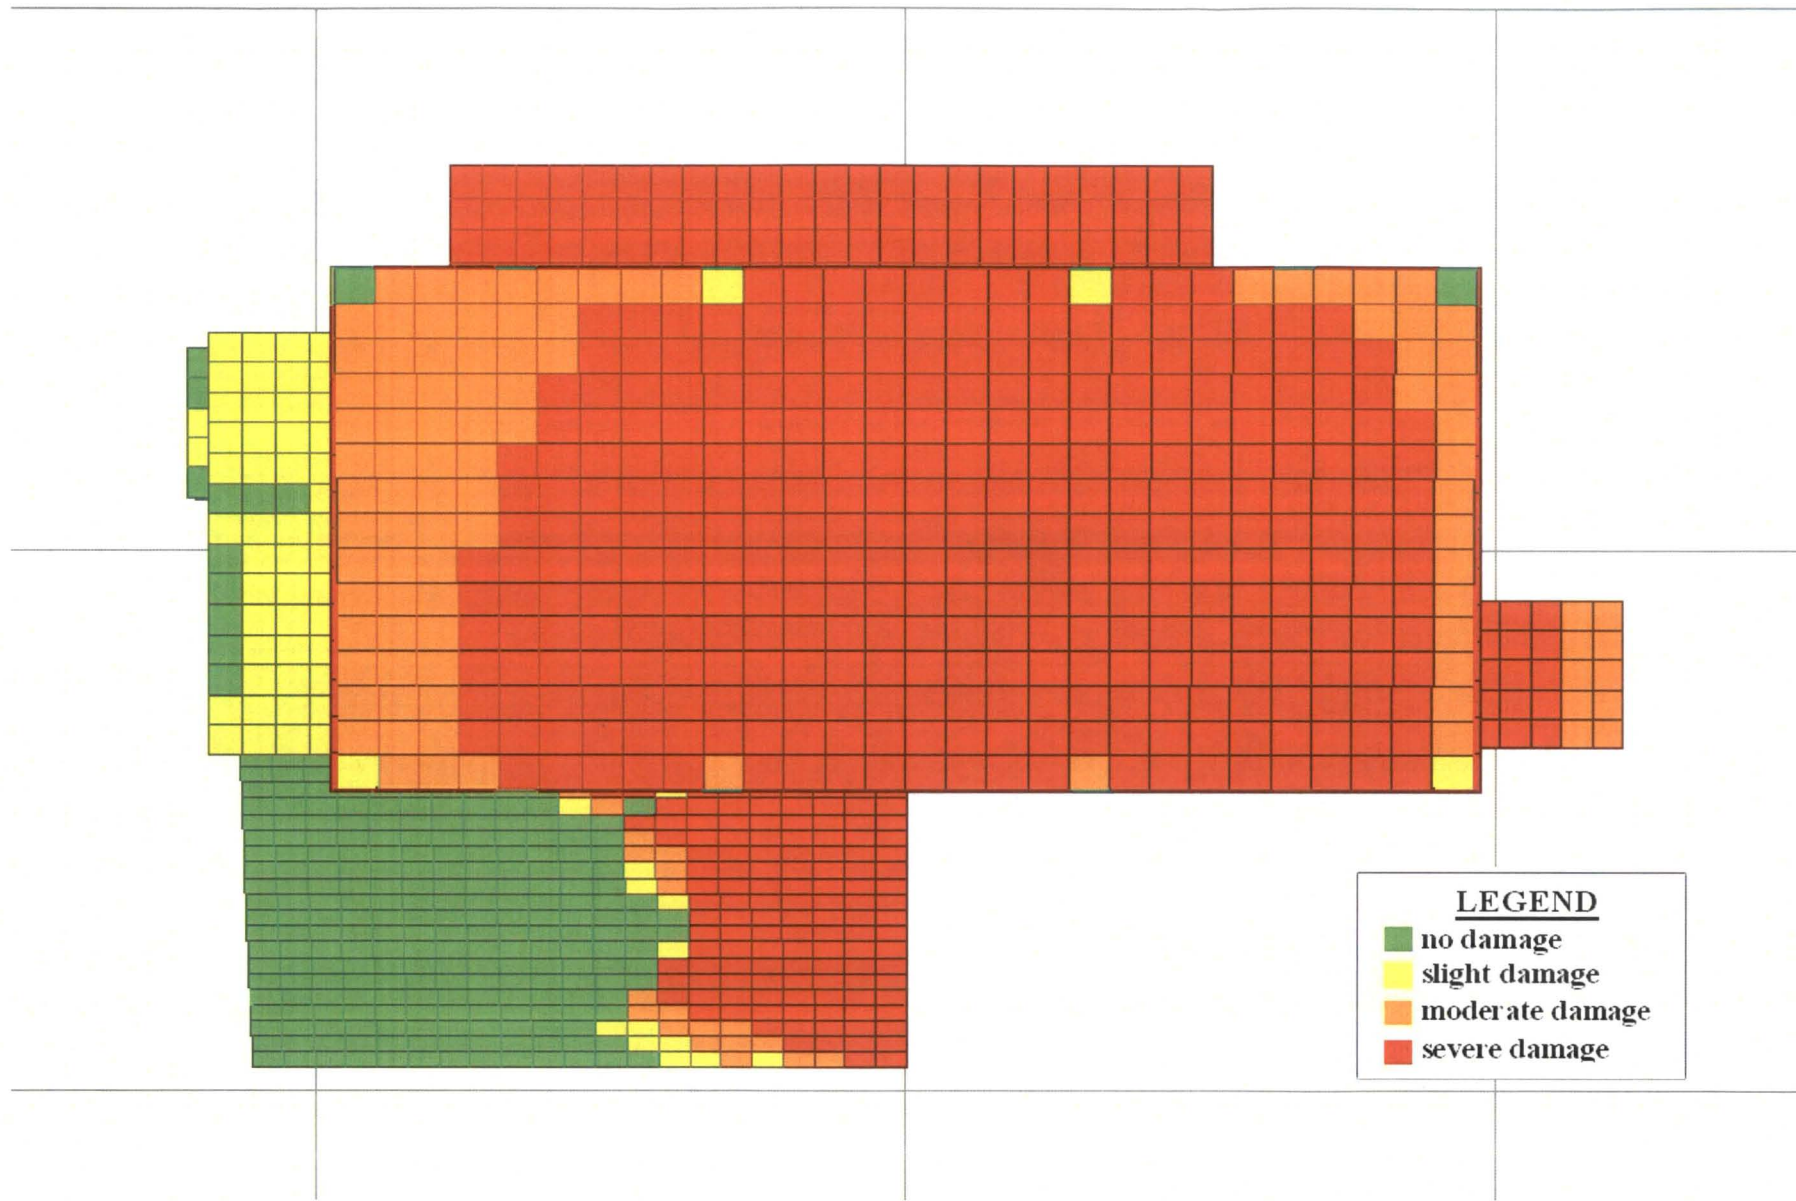
Figure 10. Damage Plot, MPPF Roof

The hypergolic fuel contained within the CEV Service Module with a total mass (including 20% design growth margin) of 21,591 lbs, was assumed to detonate with an equivalent yield of 1080 lbs of TNT. The CEV was positioned in the Access Stand within the MPPF high bay, as shown in Figure 4. All relevant components of the MPPF, both internal and external, were included in the analysis, along with all significant surrounding structures within a range of 1250 feet, or slightly further, from the MPPF. Blast effects were computed by means of the HEXDAM software [7]. Five views of the undamaged MPPF structure, as generated by HEXDAM, are presented in Figures 5 through 9. The corresponding five views of the MPPF with blast damage are presented in Figures 10 through 15. As indicated in these last five figures, severe blast damage was predicted to much of the roof, as well as all four faces of the MPPF.

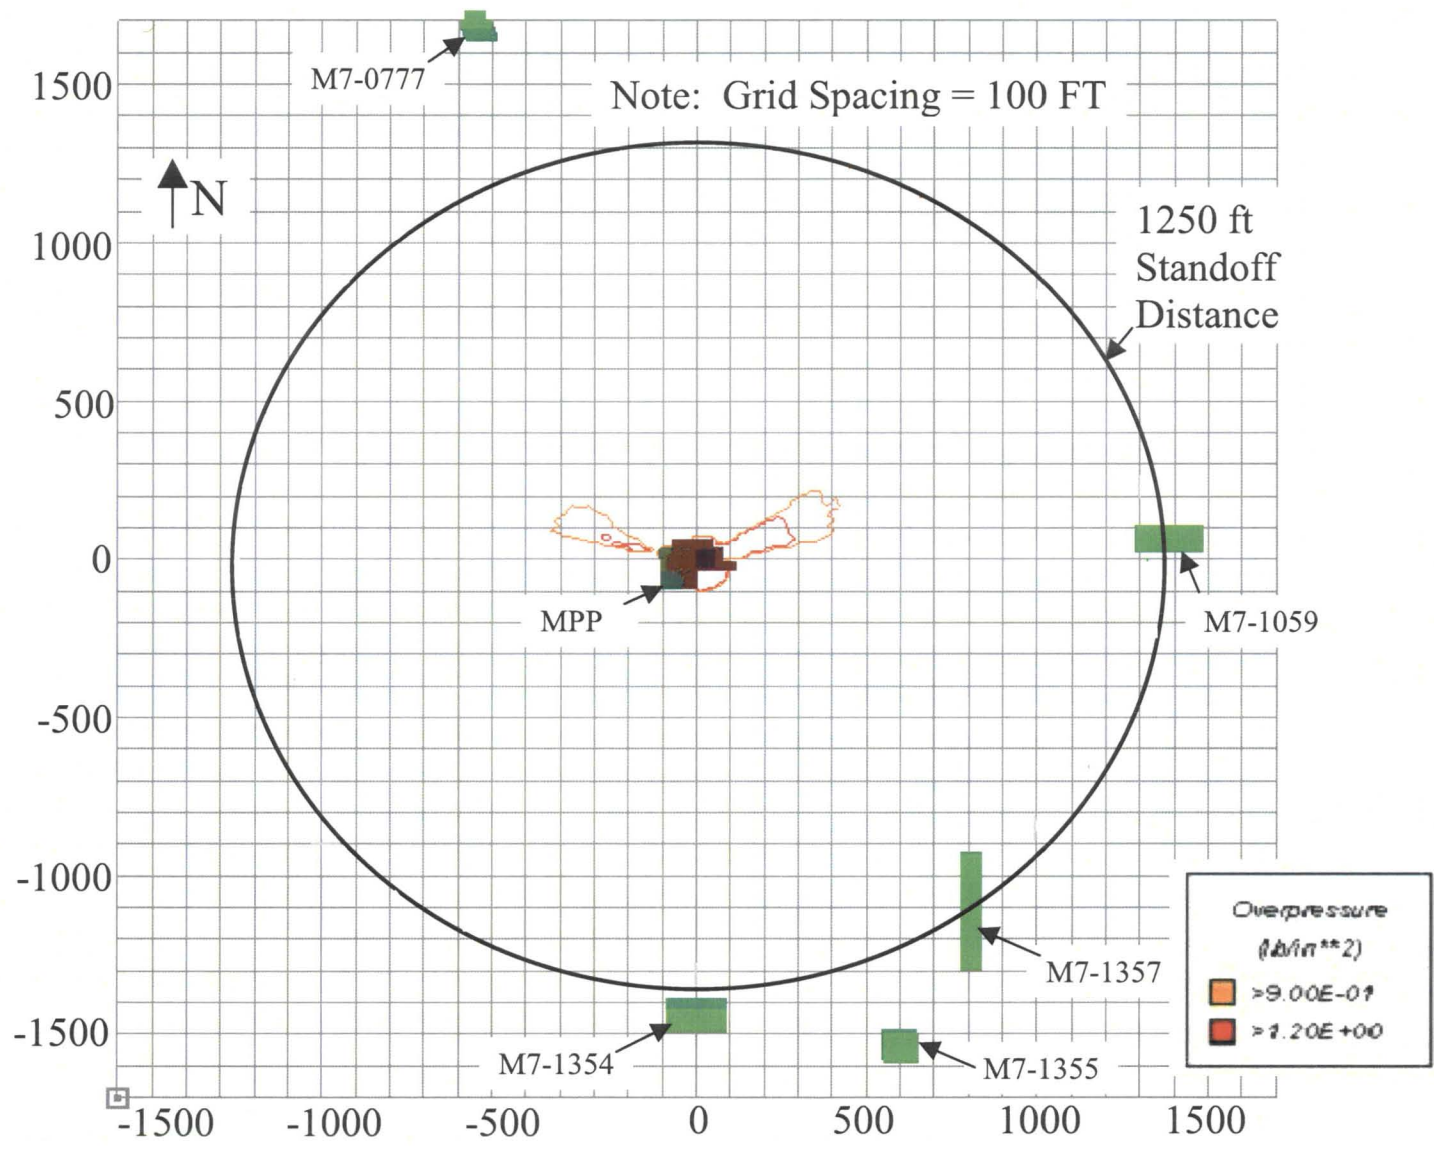
Figure 15. Horizontal Contour Plot, Overpressure (0.9 and 1.2 psi) Elevation 0 Ft.

With regard to overpressure predictions, both 0.9 and 1.2 psi horizontal contour plots were generated at eight different elevations, ranging from 0 to 70 feet. The maximum ranges for such contours occurred at 50 feet, as shown in Figure 16. As indicated in this figure, the 1.2 psi overpressure contour extended out no more than 355 feet from the MPPF perimeter while the 0.9 psi overpressure contour extended out no more than 436 feet. The results indicated significant hazard to the MPPF itself but no significant hazards to the surrounding buildings would result from blast effects. A summary of blast hazards is provided in Table 1.

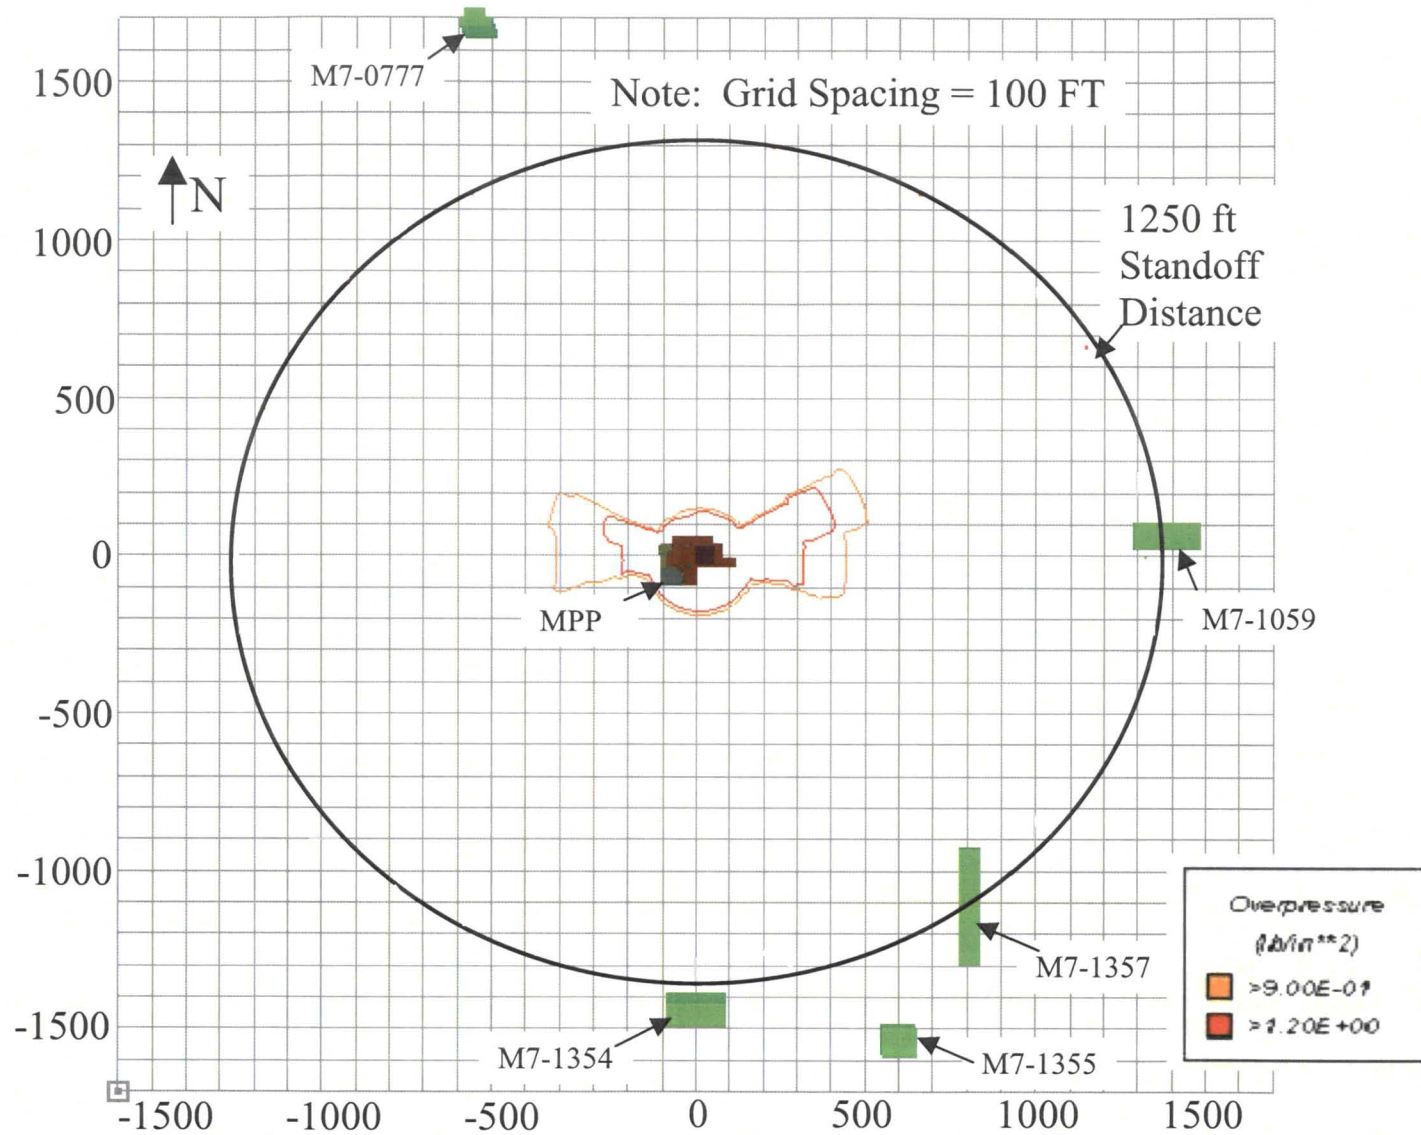
Figure 16. Horizontal Contour Plot, Overpressure (0.9 and 1.2 psi) Elevation 50 Ft.

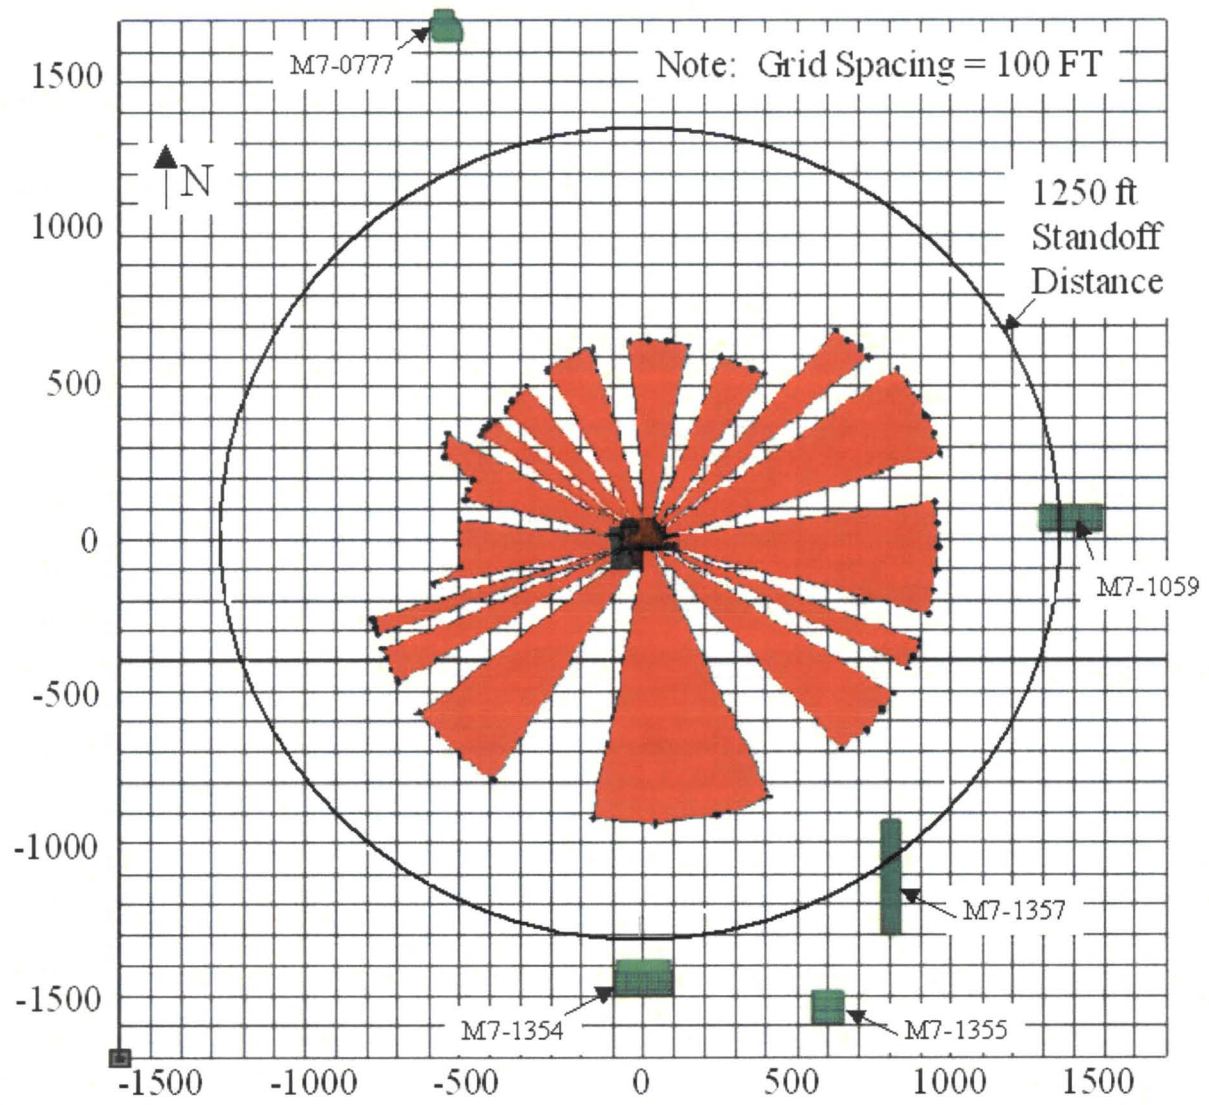
Figure 17. Primary Hazardous Fragment Range Distribution

The aluminum components within the CEV Service Module and Spacecraft Adapter were treated as a hollow cylinder which was the source of all primary fragments produced by the explosion. Characteristics of this cylindrical approximation are given in Table 2. Analyses of 88 different fragment paths were carried out by means of the PriFrag software [8]. A fragment drag coefficient of 1.2 was used in this analysis. The results indicated that 19.27% of the fragment paths were blocked by MPPF internal structures but the remaining primary fragments would impact and penetrate the MPPF wall at an elevation of approximately 18 feet. Such primary fragments were characterized by impact energies and number densities (as measured in a one-foot wide vertical plane extending from ground level up to an elevation of 6 feet), which remained hazardous at ranges out to 898 feet beyond the MPPF perimeter, as shown in Figure 17. These primary fragments appear to represent the most significant hazard to most surrounding buildings. A summary of primary fragmentation hazards is provided in Table 3.

- 1) Blast hazards are limited primarily to the MPPF.
- 2) Primary fragment hazards represent the greatest concern to surrounding KSC buildings with ranges extending out to 898 feet beyond the MPPF perimeter.

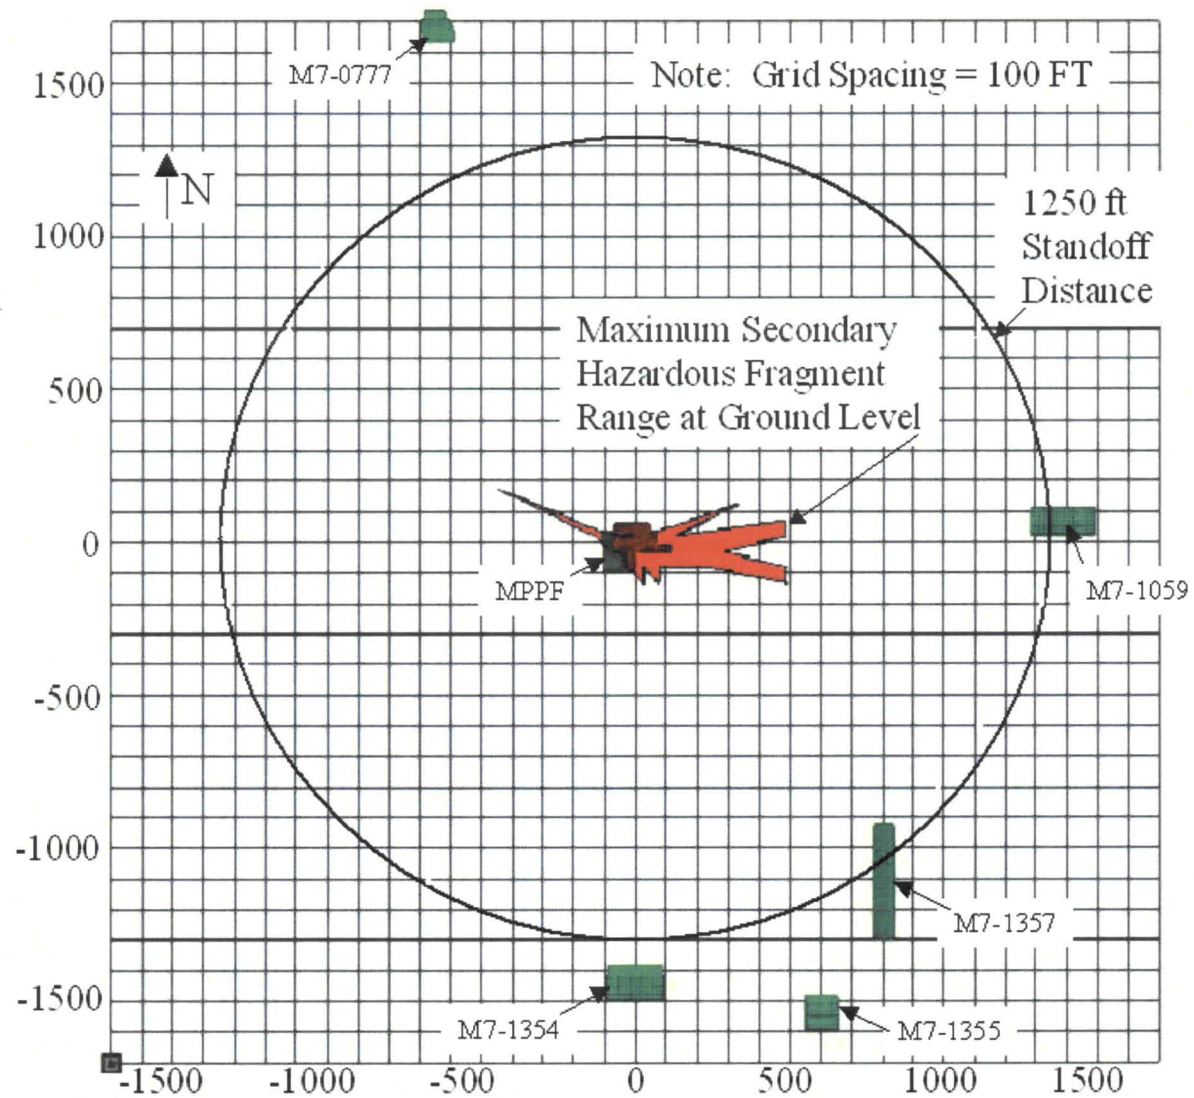
Figure 19. Secondary Hazardous Fragment Range Distribution

The secondary (external) fragments were produced by the interaction of the blast wave with the external frangible components of the MPPF high bay, where moderate or severe damage was produced. For purposes of the secondary (external) fragmentation analysis, the MPPF wall was assumed to consist of a sheet of corrugated steel. The HEXFRAG software was used with this assumption to carry out the analysis along the same 21 fragment paths previously noted. The results from the HEXFRAG runs for the secondary (internal) fragments were combined with the secondary (external) fragment results to obtain the total secondary fragment hazardous ranges. As shown in Figure 19, such ranges extended out no more than 420 feet beyond the MPPF perimeter. Such fragments appear to pose a significant hazard to the MPPF itself but no hazard to any nearby KSC structures. A summary of secondary fragmentation hazards is provided in Table 4.

Secondary hazardous fragment ranges extend out no more than 420 feet and pose minimal hazard to nearby KSC structures.
